## **Viscous Oil Recovery and Pumping Research in Canada**

### **Abstract**

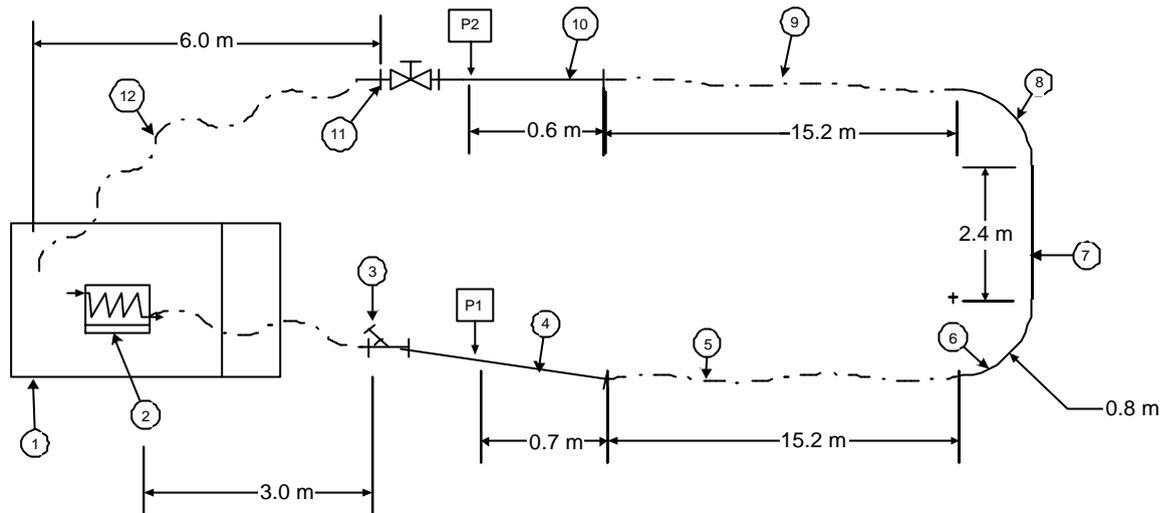
**Figure 1 Testing Loop (10.2 cm - 4")**

Test loops were designed for each of the skimmers, based in part upon previous test loop designs that pumped oil with viscosities approaching 30,000 cP (Moffat, 2000, Loesch et al, 2000). The loops consisted of flow straightening sections with pressure sensors, piping curves, and hose segments that allowed the overall length of the circuits to be changed when desired during testing.

- P1 & P2: Pressure measurement ports.

The full length of the 10.2 cm (4") loop was used for the Bunker C (a heavy fuel oil) tests. This loop consisted of flow straighteners (1.3 m), hose lengths (30.4 m), and a rigid return loop (4.0 m). Oil was pumped into the hopper of the skimmer, which was run at a slow speed while the test loop filled with oil. Excess oil was poured into the holding tank and the system was left to stabilize for approximately 10 minutes. The data logger was activated and after a short period of time (typically 2 minutes) pressure readings from the gauges were obtained. The time required to pump the liquid into a container of known volume was then measured, and the flowrate was calculated. Once this measurement was obtained, the datalogger was stopped, and the datafile was saved. The speed of the skimmer was then changed, and the system was again left to stabilize for approximately 10-15 minutes. This scenario was repeated until four speeds were recorded. Data from this series of runs is presented in Table 1, while a picture of the GT 185 is presented in Figure 2.

A shortened section of the 10.2 cm (4") loop was used for the bitumen runs. This loop consisted of the same flow straighteners (1.3 m) and rigid return loop (4.0 m), however the hose length was reduced to an overall measurement of 13.7 m to account for the limited quantity of bitumen on hand, and the expected high resistance to flow throughout the test loop.

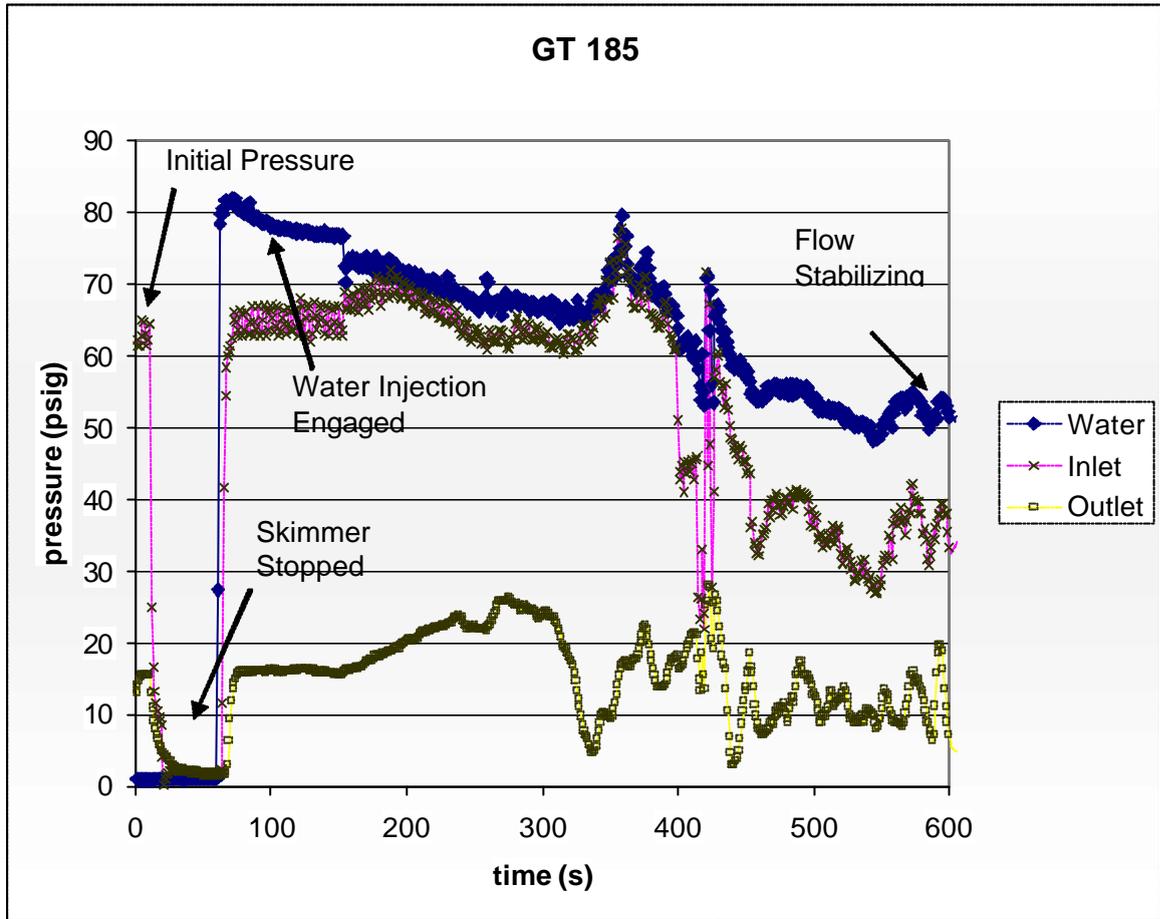
**Figure 3 Testing Bitumen with Annular Ring 10.2 cm (4")**

Testing with the annular water injection ring produced also provided interesting results. The system was run up to an inlet pressure of approximately 4.4 bar (64 psi) and left to stabilize. The skimmer was then momentarily stopped and the water injection ring was engaged. The skimmer was then brought back online and the system was left to stabilize (see Figure 3). As the system stabilized, the pressure drop was slower to stabilize, but levelled off within minutes. A flowrate measurement was performed and flows were recorded as shown in Table 3.

An observed inlet pressure reduction of approximately 45% was recorded with the annular water ring operating. It should be noted, however, flowrates remained relatively low, and that no annular flow was observed to have developed through the outlet. It was expected that a larger drop in initial and loop pressure would be observed if the annular water ring was established.

The annular water injection ring was successful in reducing the pressure requirements during pumping with the GT185, however it could not be confirmed that the water ring successfully formed within the test loop. Output from the hose seemed to indicate some mixing of the oil and water was occurring but readily separated once discharged. The

reduction in pressure requirements could be attributed to two phased flow within the test loop, as opposed to the formation of an annular ring.

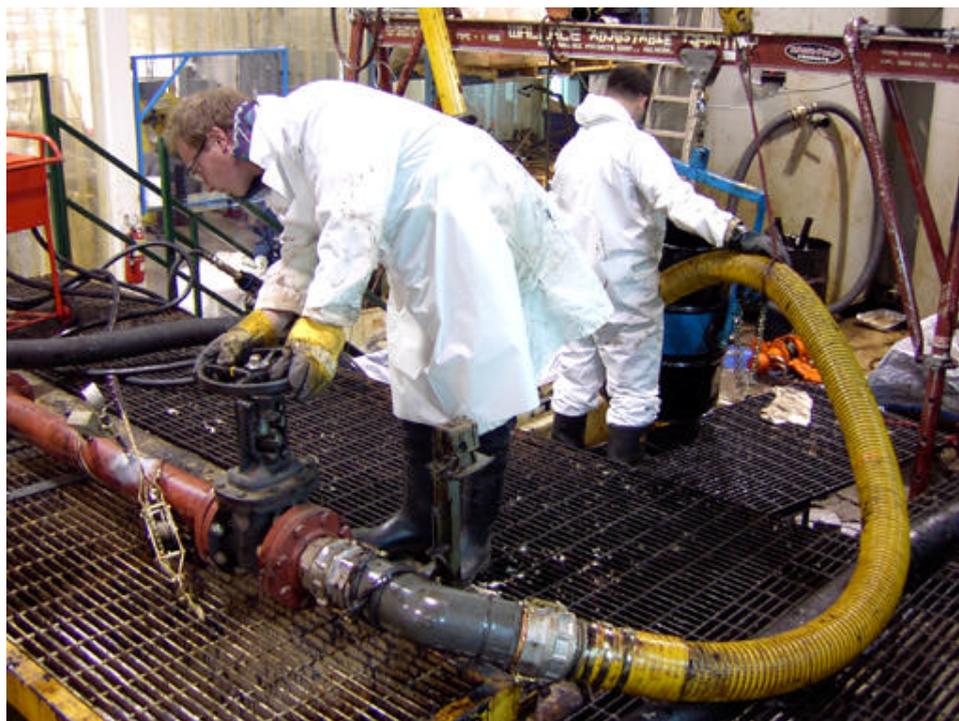
**Figure 4: Test Loop**

Testing during the third phase was performed using bunker C), a viscous oil (bitumen) and water for baseline testing. Two loops were used during the testing. The first consisted of approximately 4 metres (12 feet) of hose, connected to a 2 metre (6 foot) pipe with pressure sensors, a valve to regulate backpressure, and a return 45° angle plus hose approximately 4.5 metres (14 feet) long. The bitumen tests were run using a 8 metre (25 foot) section of hose.

Two “working tanks” were installed and acted as the staging areas for all test runs. The first tank had a capacity of approximately 1.6 m<sup>3</sup>. This was used as the working tank for all of the water runs. A second tank, dedicated for oil use, had a capacity of approximately 2.4 m<sup>3</sup>. Both tanks were constructed of high density polyethylene with an external supplemental metal support framework on the outside. The GT 185 pumps were placed in the working tanks and pumped testing liquid through the loops in a recirculating fashion. Pressure and temperature sensors were attached to a datalogger, with manual readings being measured as a backup once each run had stabilized.

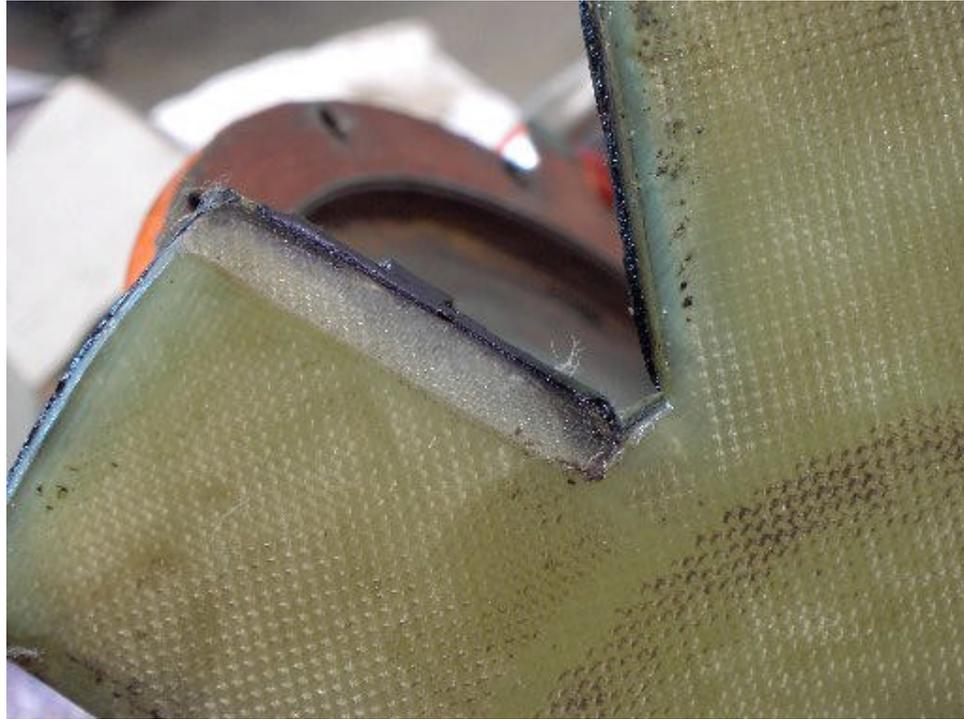
**Figure 5: #1153-2 plate wheel after 3 hours**

The results of the stock GT 185 system “1153-1” using a new plate wheel were very good. At this time, the original plate wheel that came in the stock GT 185 (GT185-01-90) was installed and given a designation of “1153-2”. This would allow data to be generated on equipment that matched the condition of equipment in CCG inventory.

The measured values did not seem to correlate with the apparent wear that was being caused by the pumping of extremely viscous product over the test periods. Upon detailed examination, however, evidence shows that wear is occurring not only upon the seals but also on the support structure. The impact of this damage on the lifespan of the disk wheel is not known, but the damage seemed to occur early in the testing which is cause for concern. The damage may also be due to the ‘break in’ period for this pump, and may reach a steady state during extended use. The new prototype was able to provide impressive results, surpassing stock equipment for maximum pressures attained during baseline water testing.

The stock disk wheels did not stand up well to the testing. As a result of these findings problems should be expected if the stock disk wheels are used while attempting to pump highly viscous product such as bitumen. Additionally, hot water injection at the inlet side of the pump which may be attempted in order to overcome some of the difficulties in moving the bitumen is not recommended due to the degradation of the stock disk wheel witnessed during our testing.
