**Chemical Spill in Latin American Port Areas: Lessons learned in Panama**  
**with the Spill of the Chloropivaloyl Chloride**

**Author: Ruben Reyna\***

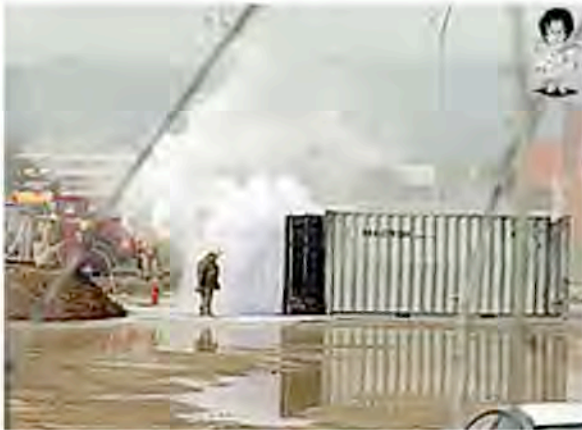
Figure 1

Toxic Cloud from self ignited Sodium Hydrosulfite

The cause of the cloud was a container stuffed with Sodium Hydrosulfite, used as textiles bleach and is commonly used in several assembly plants industries inside Special Processing Zones of these Central American countries. Even that the Port Authority stored the container in a segregated area, the fact that the product is normally transported and kept in the port, caused that the personnel lost the alertness. The product is also classified as flammable and combustible material in certain circumstances (IMDG). The container with the chemical was not properly stored. The product was kept on the container yard, which allows moisture to penetrate the container during the heavy rain season. This chemical needs only moisture to ignite so the air humidity could be enough if a seal is not working properly. Such situations are not new in Latin America and periodically reoccur in any of its ports. Bureaucratic procedures not properly made ignorance, inadequate budgets, and misguided priorities by the authorities. There are many things working together contributing to the occurrence of these accidents. Effective prevention and responses and are still slow in many public ports, and even in Latin America private ports.

Spills like this will always occur. The main issue is that the lessons are not learned everywhere; they probably believed their response was satisfactory. After all there were no fatal victims. The firefighters were happy. They poured water and the fire was extinguished. They did not realize that they were contributing to create more toxic vapors. The correct procedure is to form a mist to cool down the container, not a gush of water.

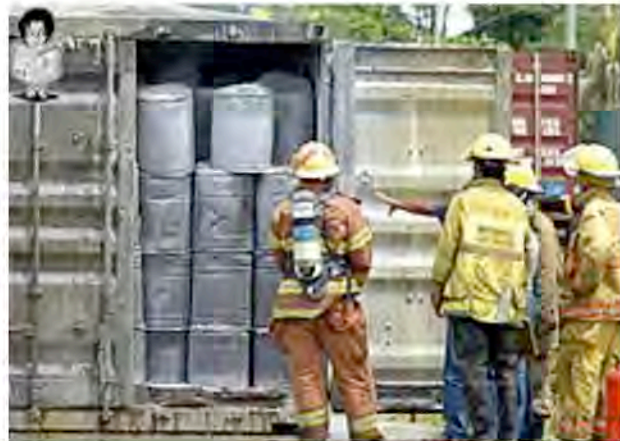
Figure 2

The Firemen finally opened the container

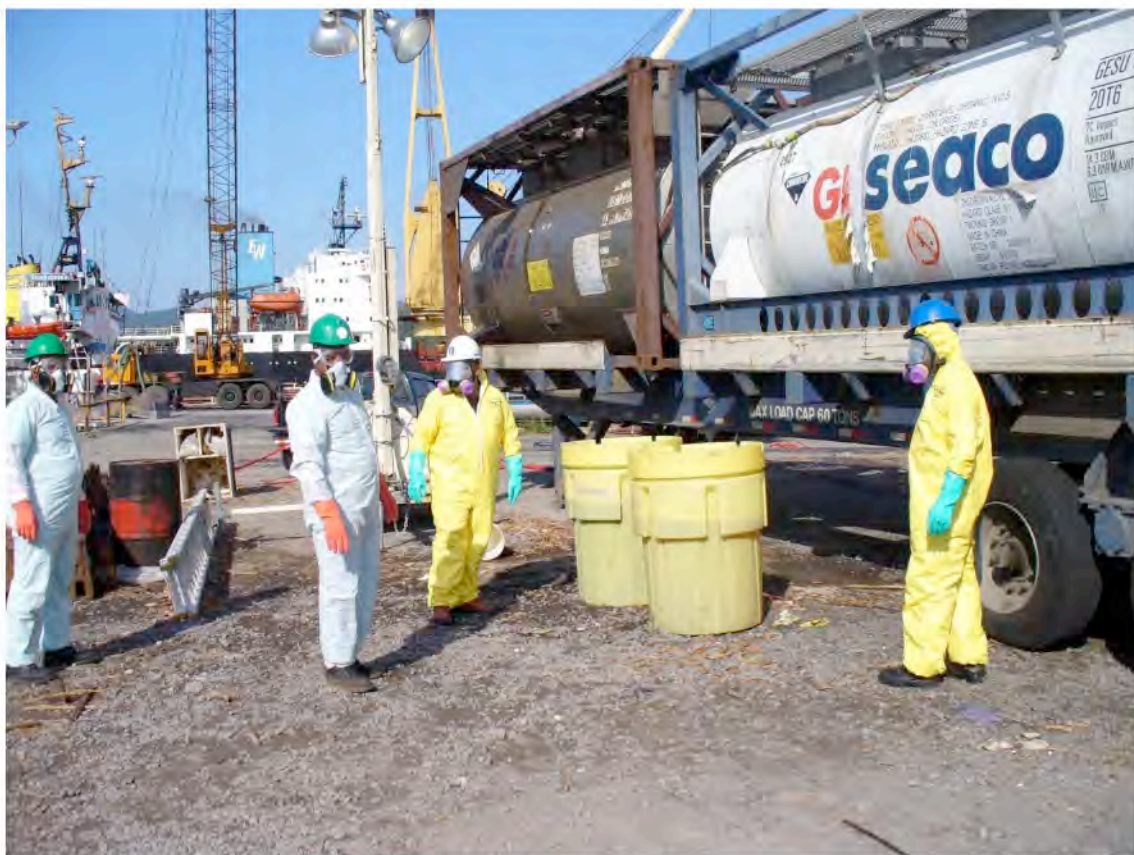
Figure 5

First response at the port. The personnel are wearing protective equipment and full face mask.

The protective equipment was not the best for the situation, we can say that some good level of protection was achieved, but the spill was controlled and the acid contained.

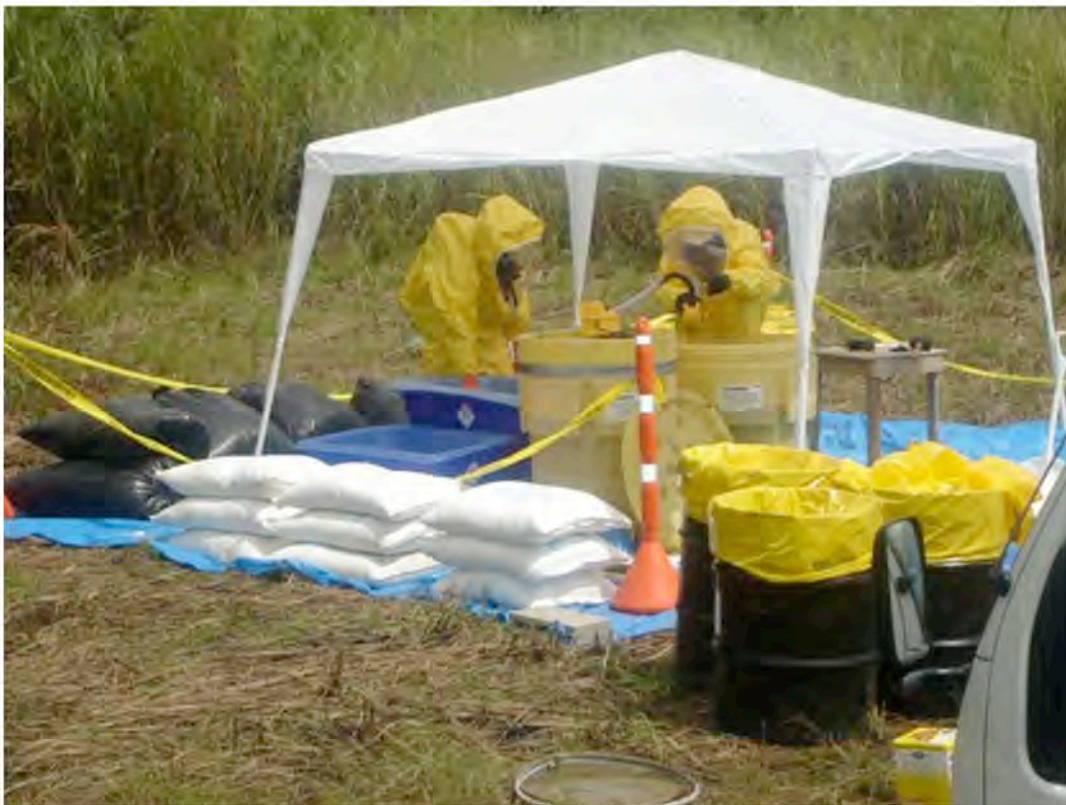
Figure 6

The personnel are ready to start the neutralization of the Chloride.

1. An isolated place was selected in order to avoid people in the vicinity. Heavy toxic fumes were known to be produced.
2. The product was mixed with a the soda ash and water, very slowly in order to achieve a pH of 7-8

3. Once the acidity was neutralized, very dry saw dust was aggregated to absorb the product. Then was placed in plastic bags. The yellow bags that can be appreciated in figure 6. Because of the high temperatures

normal in Panama, the personnel had to be shifted every 30 minutes to have a break and cool themselves.

4. Once the process finished, the personnel and tools was decontaminated by extra personnel who has only the clean up function.
5. The product was then transported to the incinerator and burned in two stages. First one at 800 °C and the second one at around 1,150 °C
6. The ashes were confined in concrete coffins in order to be buried at a proper site.
7. A final disposition certificate was issue to the original carrier of the acid.
