Issues from Containership Incidents

Andrew Tucker – Senior Technical Adviser

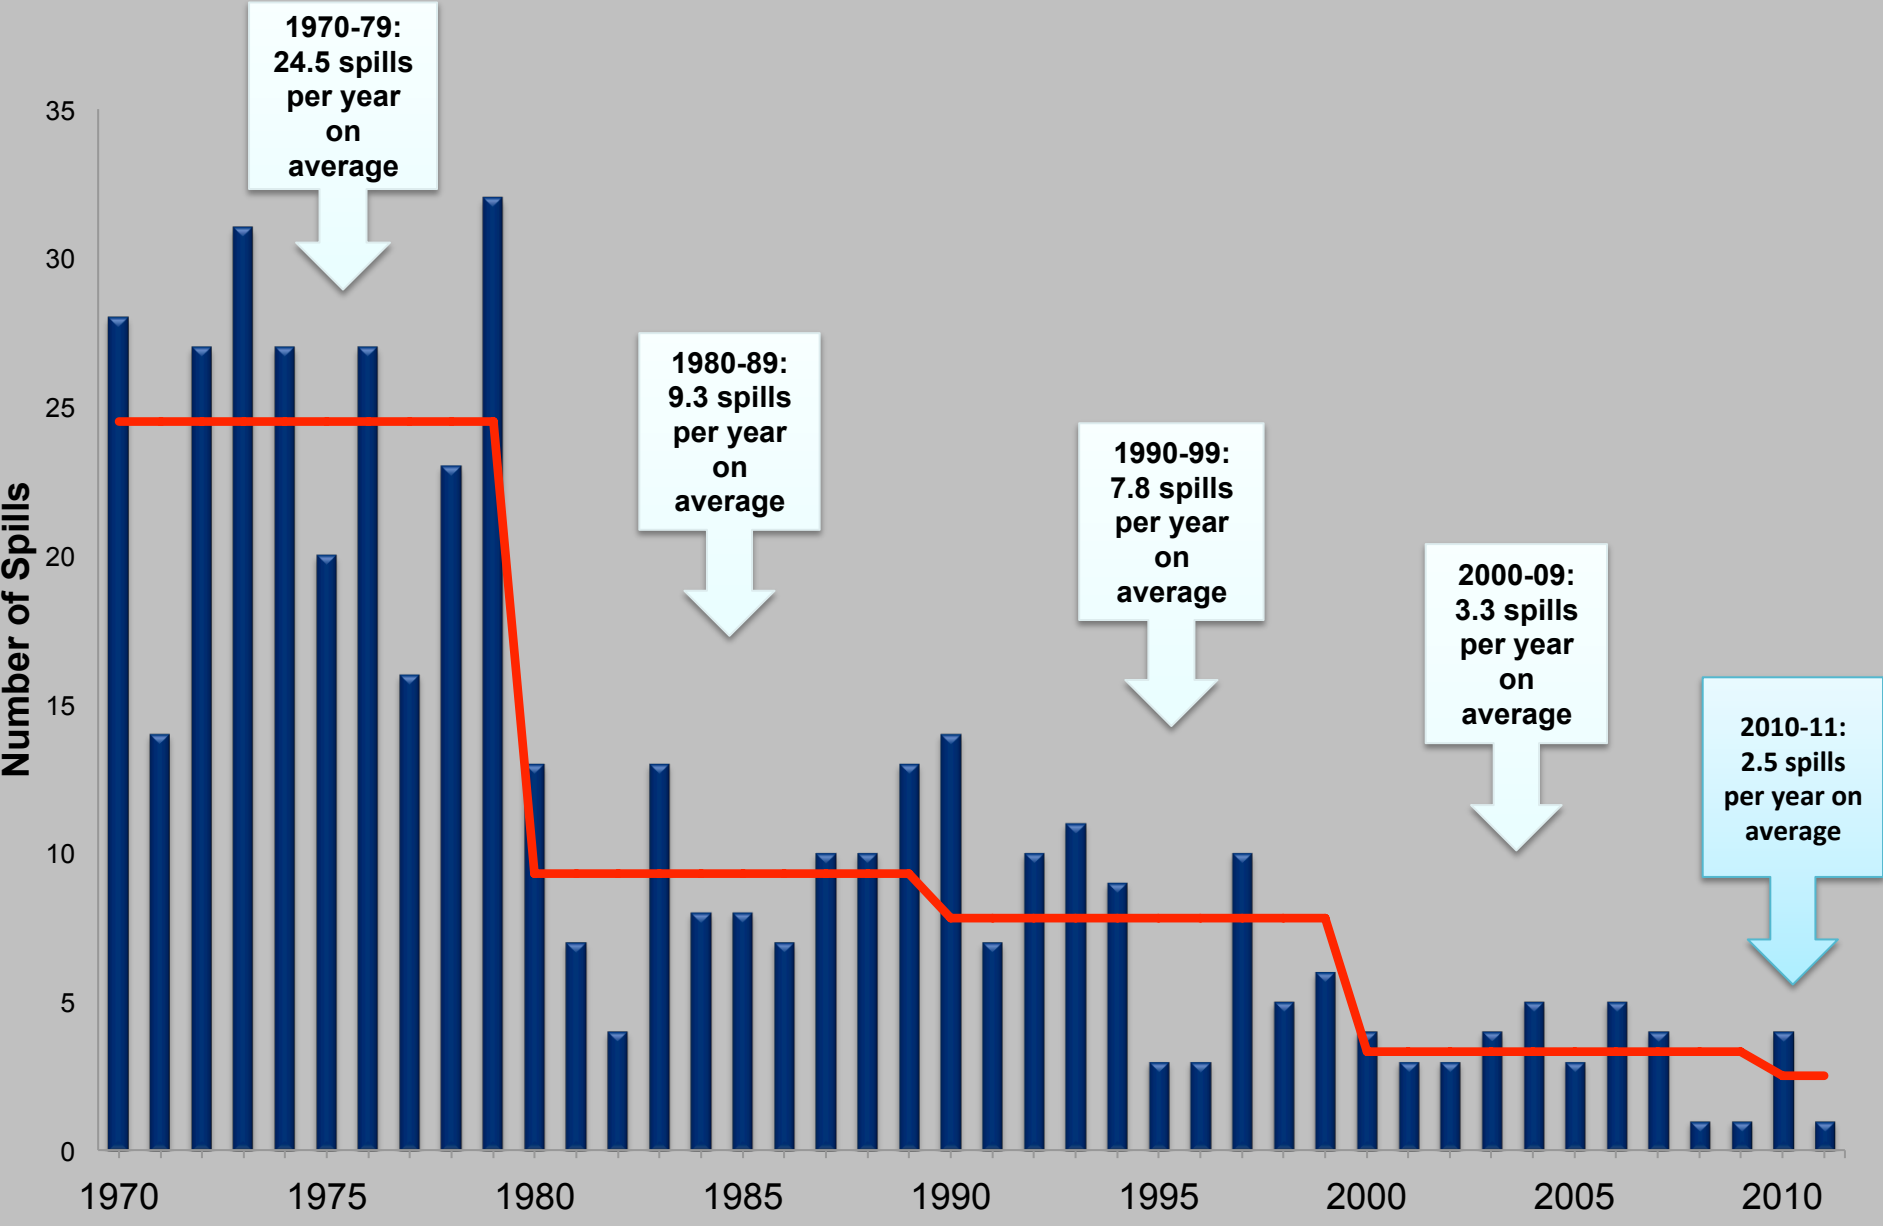
Number of large oil spills (over 700 tonnes)

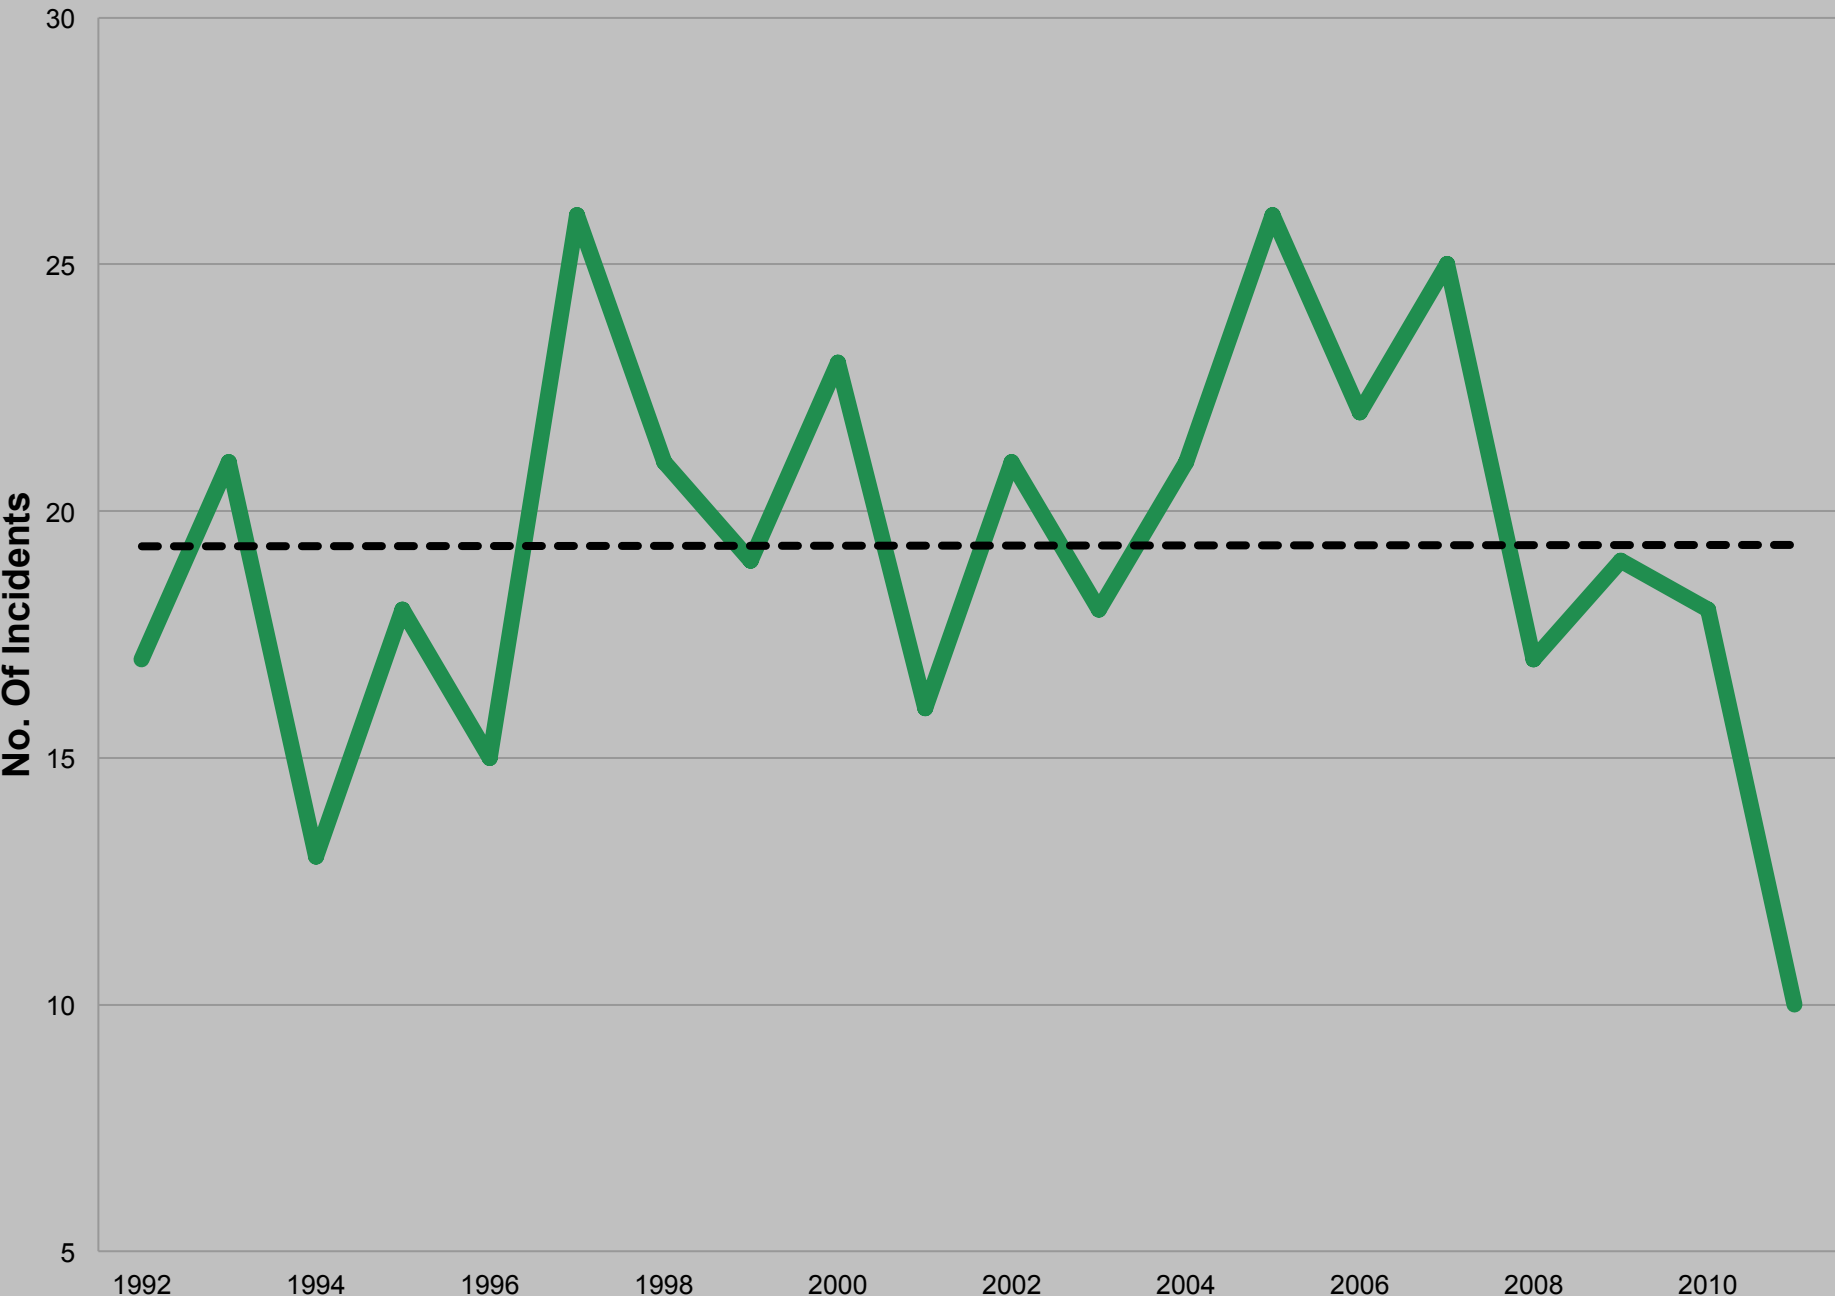
ITOPF attendance on site for Shipping Incidents

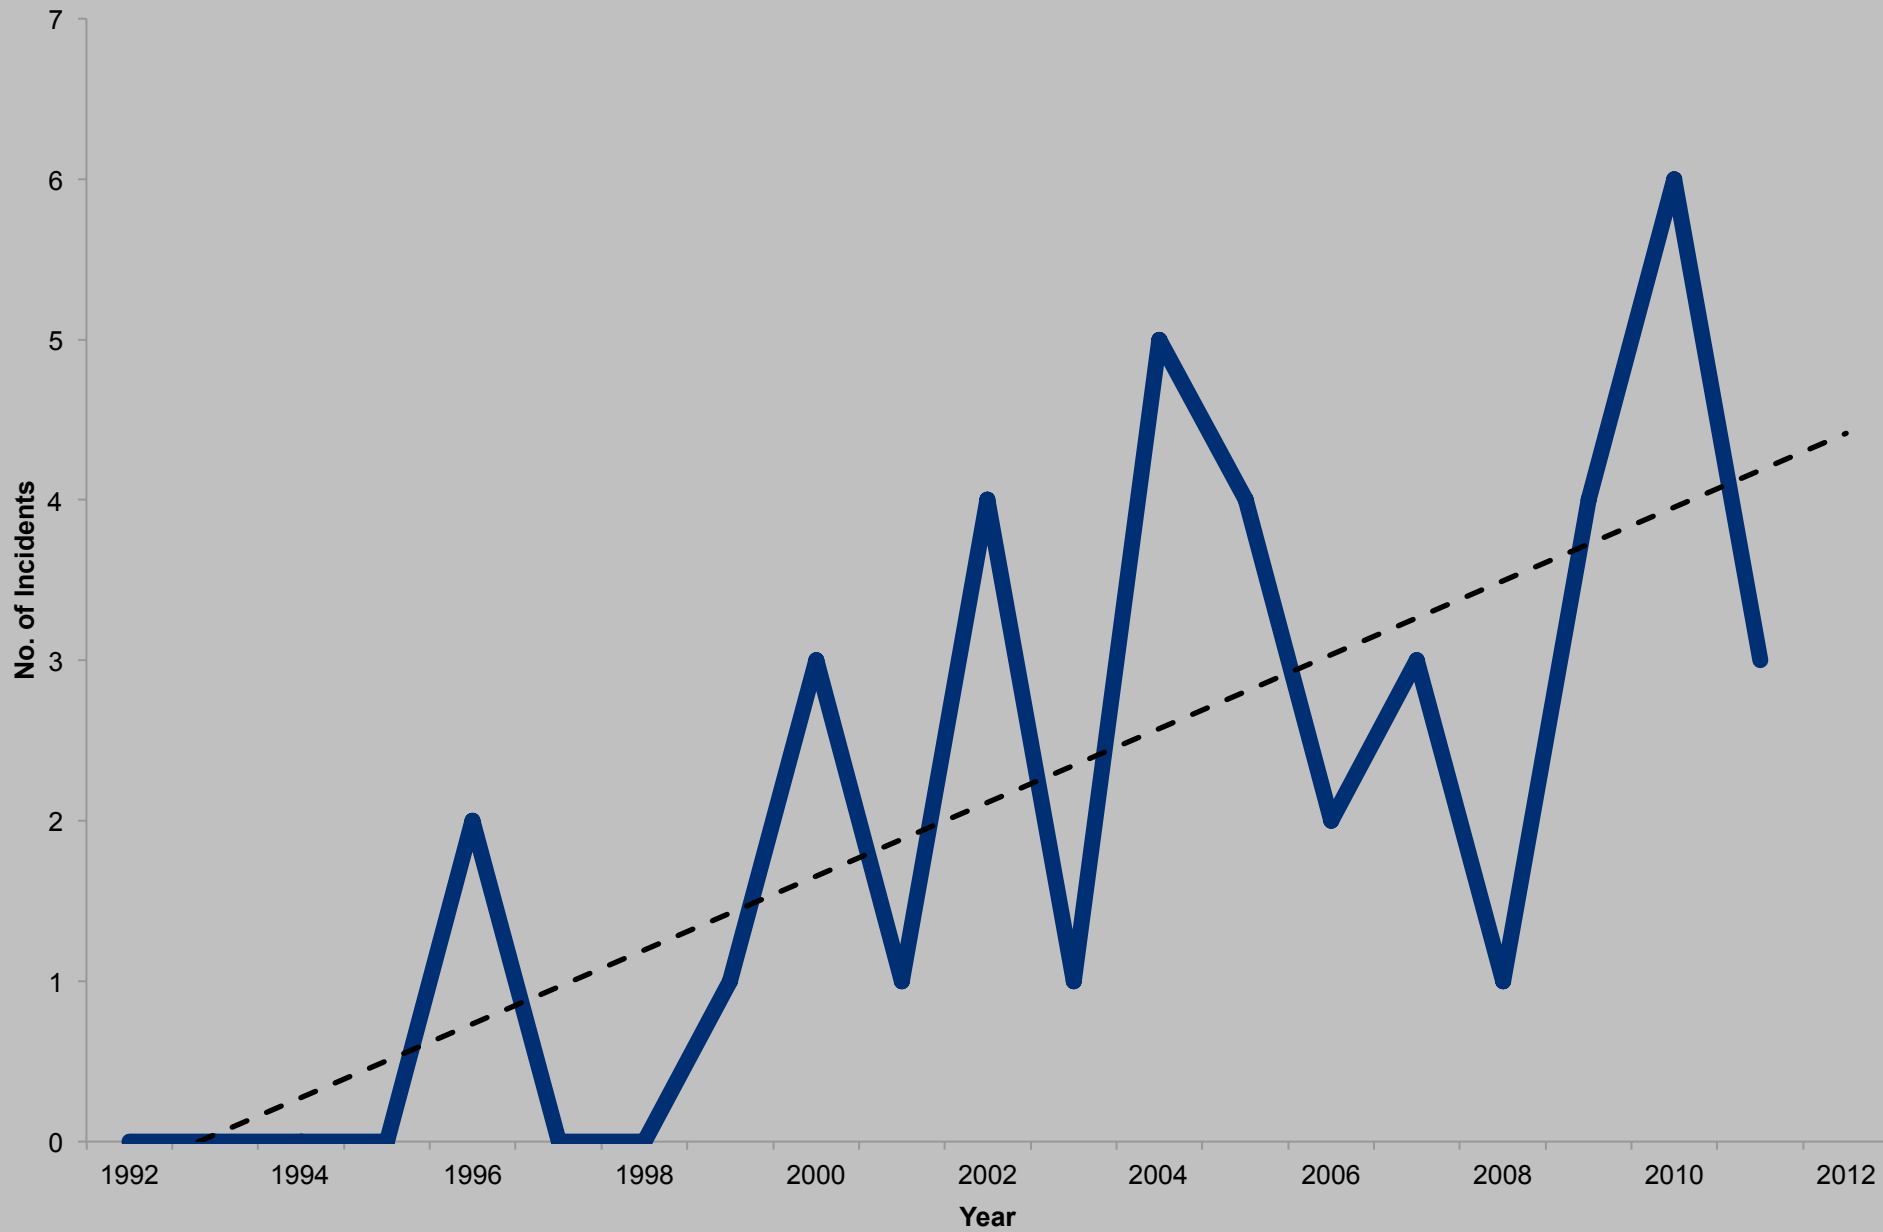
Frequency of ITOPF attendance at Containership Incidents

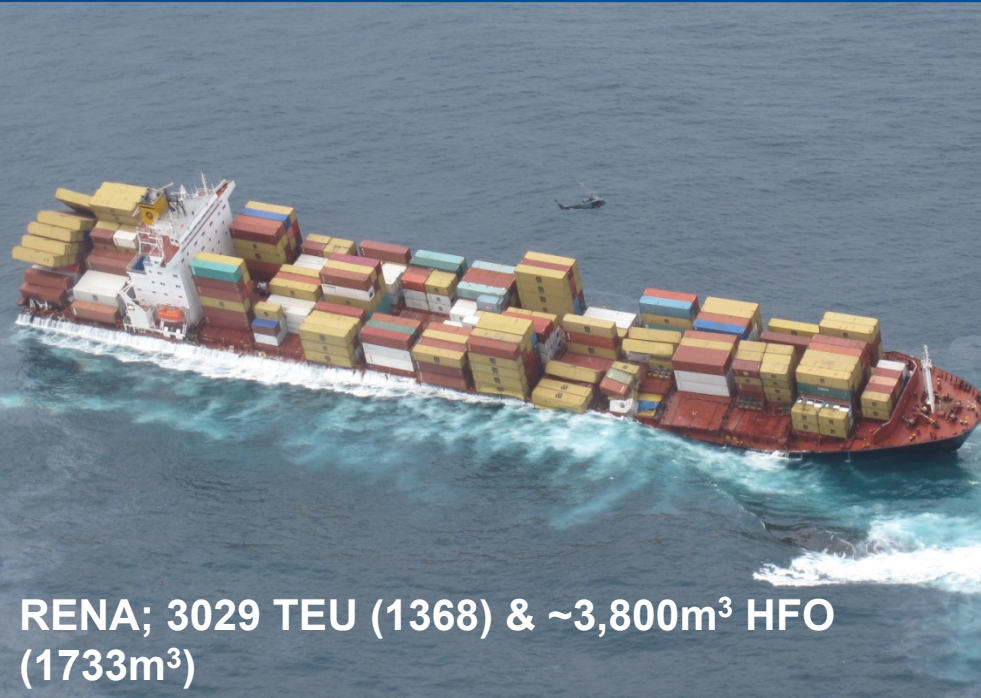
RENA; 3029 TEU (1368) & ~3,800m³ HFO (1733m³)

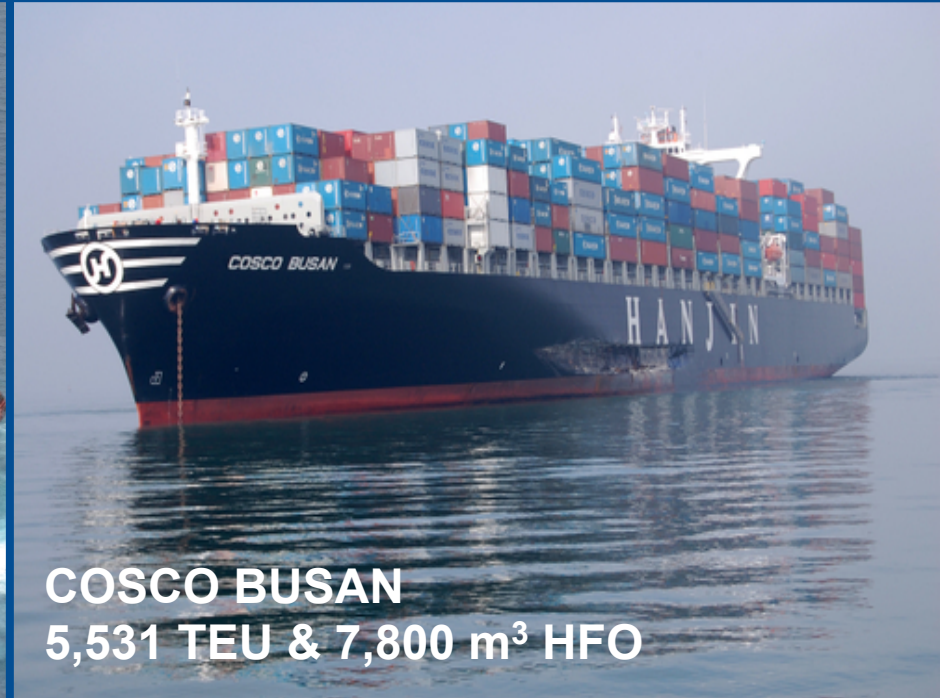
**COSCO BUSAN
5,531 TEU & 7,800 m³ HFO**

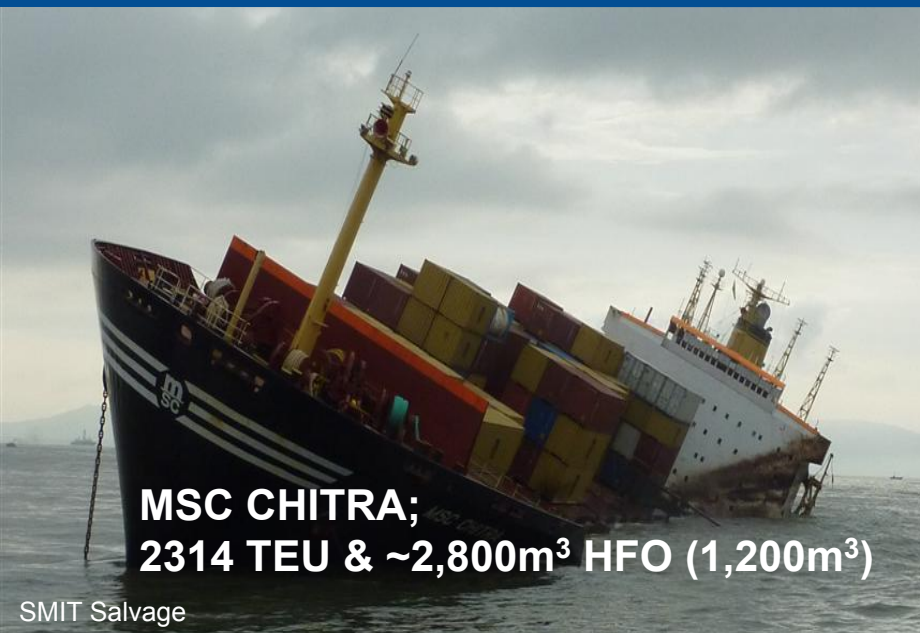
**MSC CHITRA;
2314 TEU & ~2,800m³ HFO (1,200m³)**

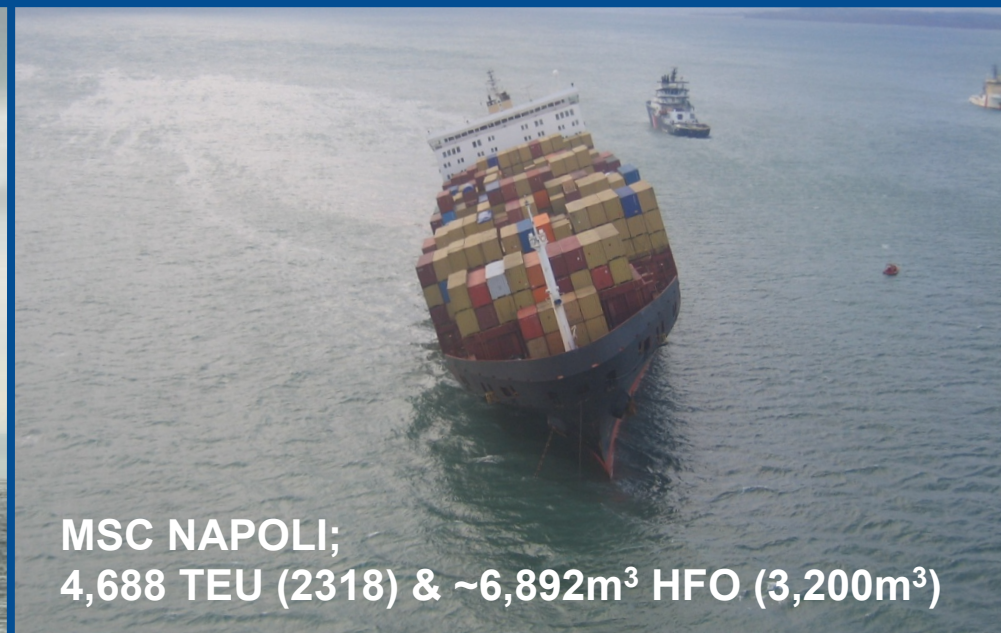
**MSC NAPOLI;
4,688 TEU (2318) & ~6,892m³ HFO (3,200m³)**

Oil and containers lost

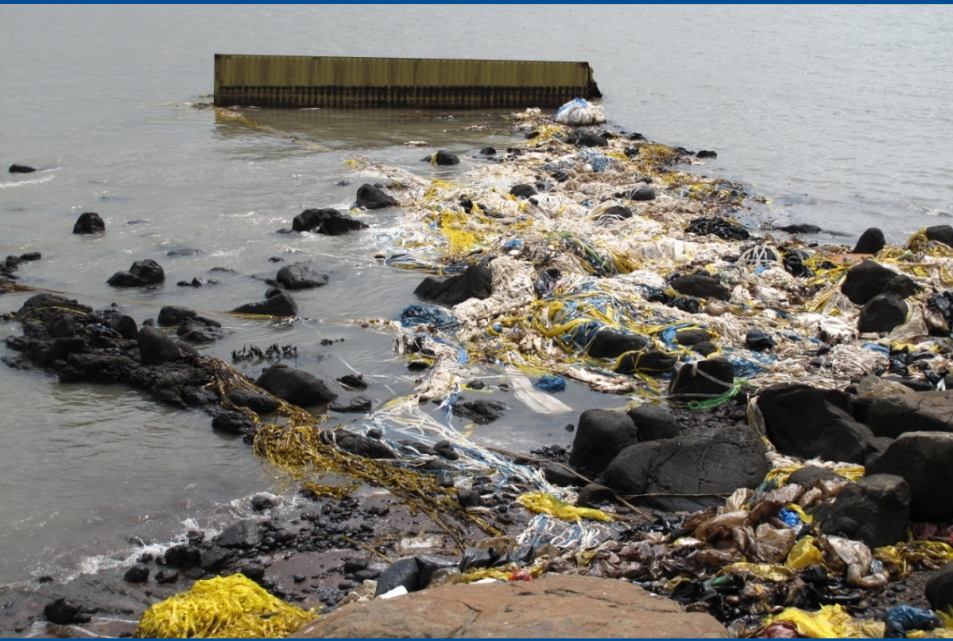
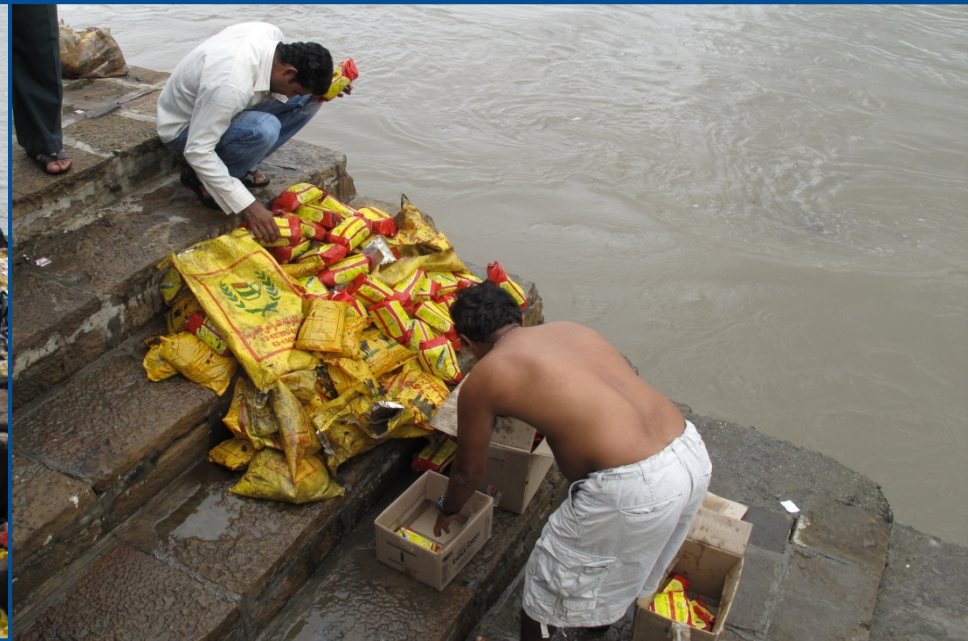
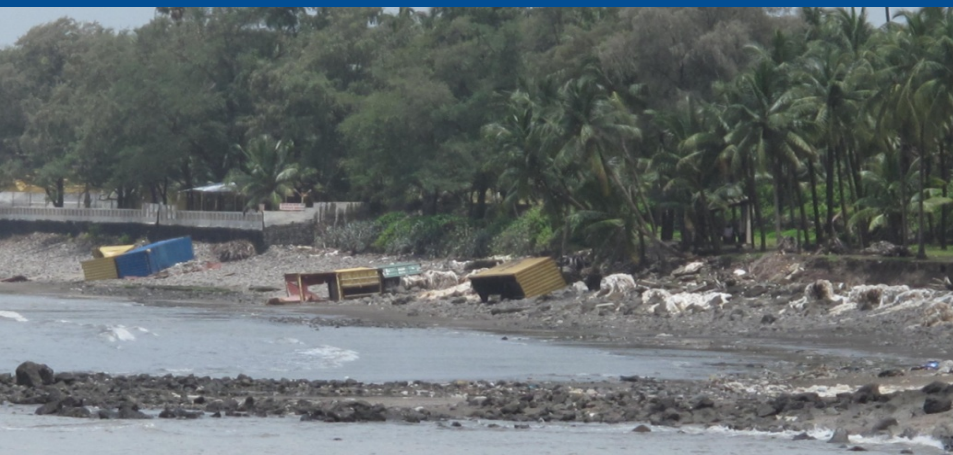
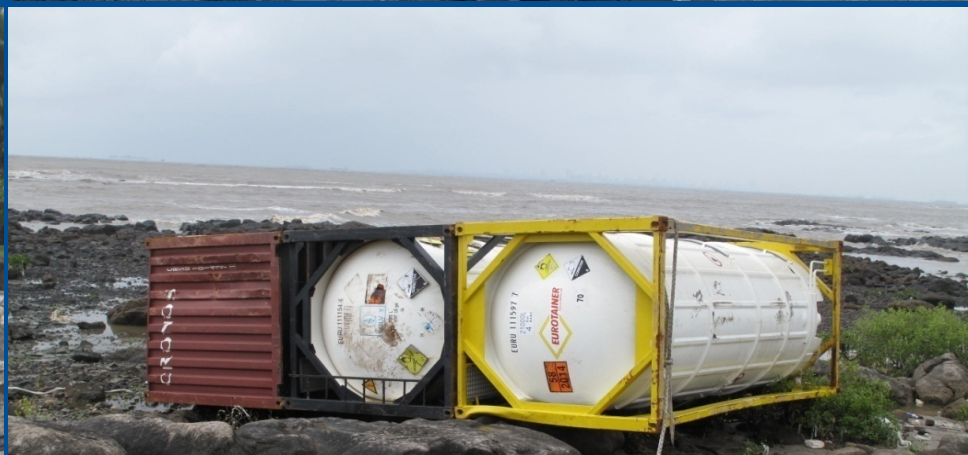
Diversity of Container contents

- **Organic materials:** Tea, waste plastic and paper for recycling, cocoa beans, logs, pineapples, sisal (fibre) bags, paper rolls
- **Metallic:** coiled steel rolls, aluminium cans, galvanised steel, fabricated steel structures
- **Chemical:** paraffin, soda ash (Na_2CO_3), glucose, pharmaceuticals, fertilizers, polypropylene, resins, solvents, Hydrogen Peroxide (H_2O_2), fungicide (AIP)
- **Miscellaneous:** personal items, clothing, shoes.

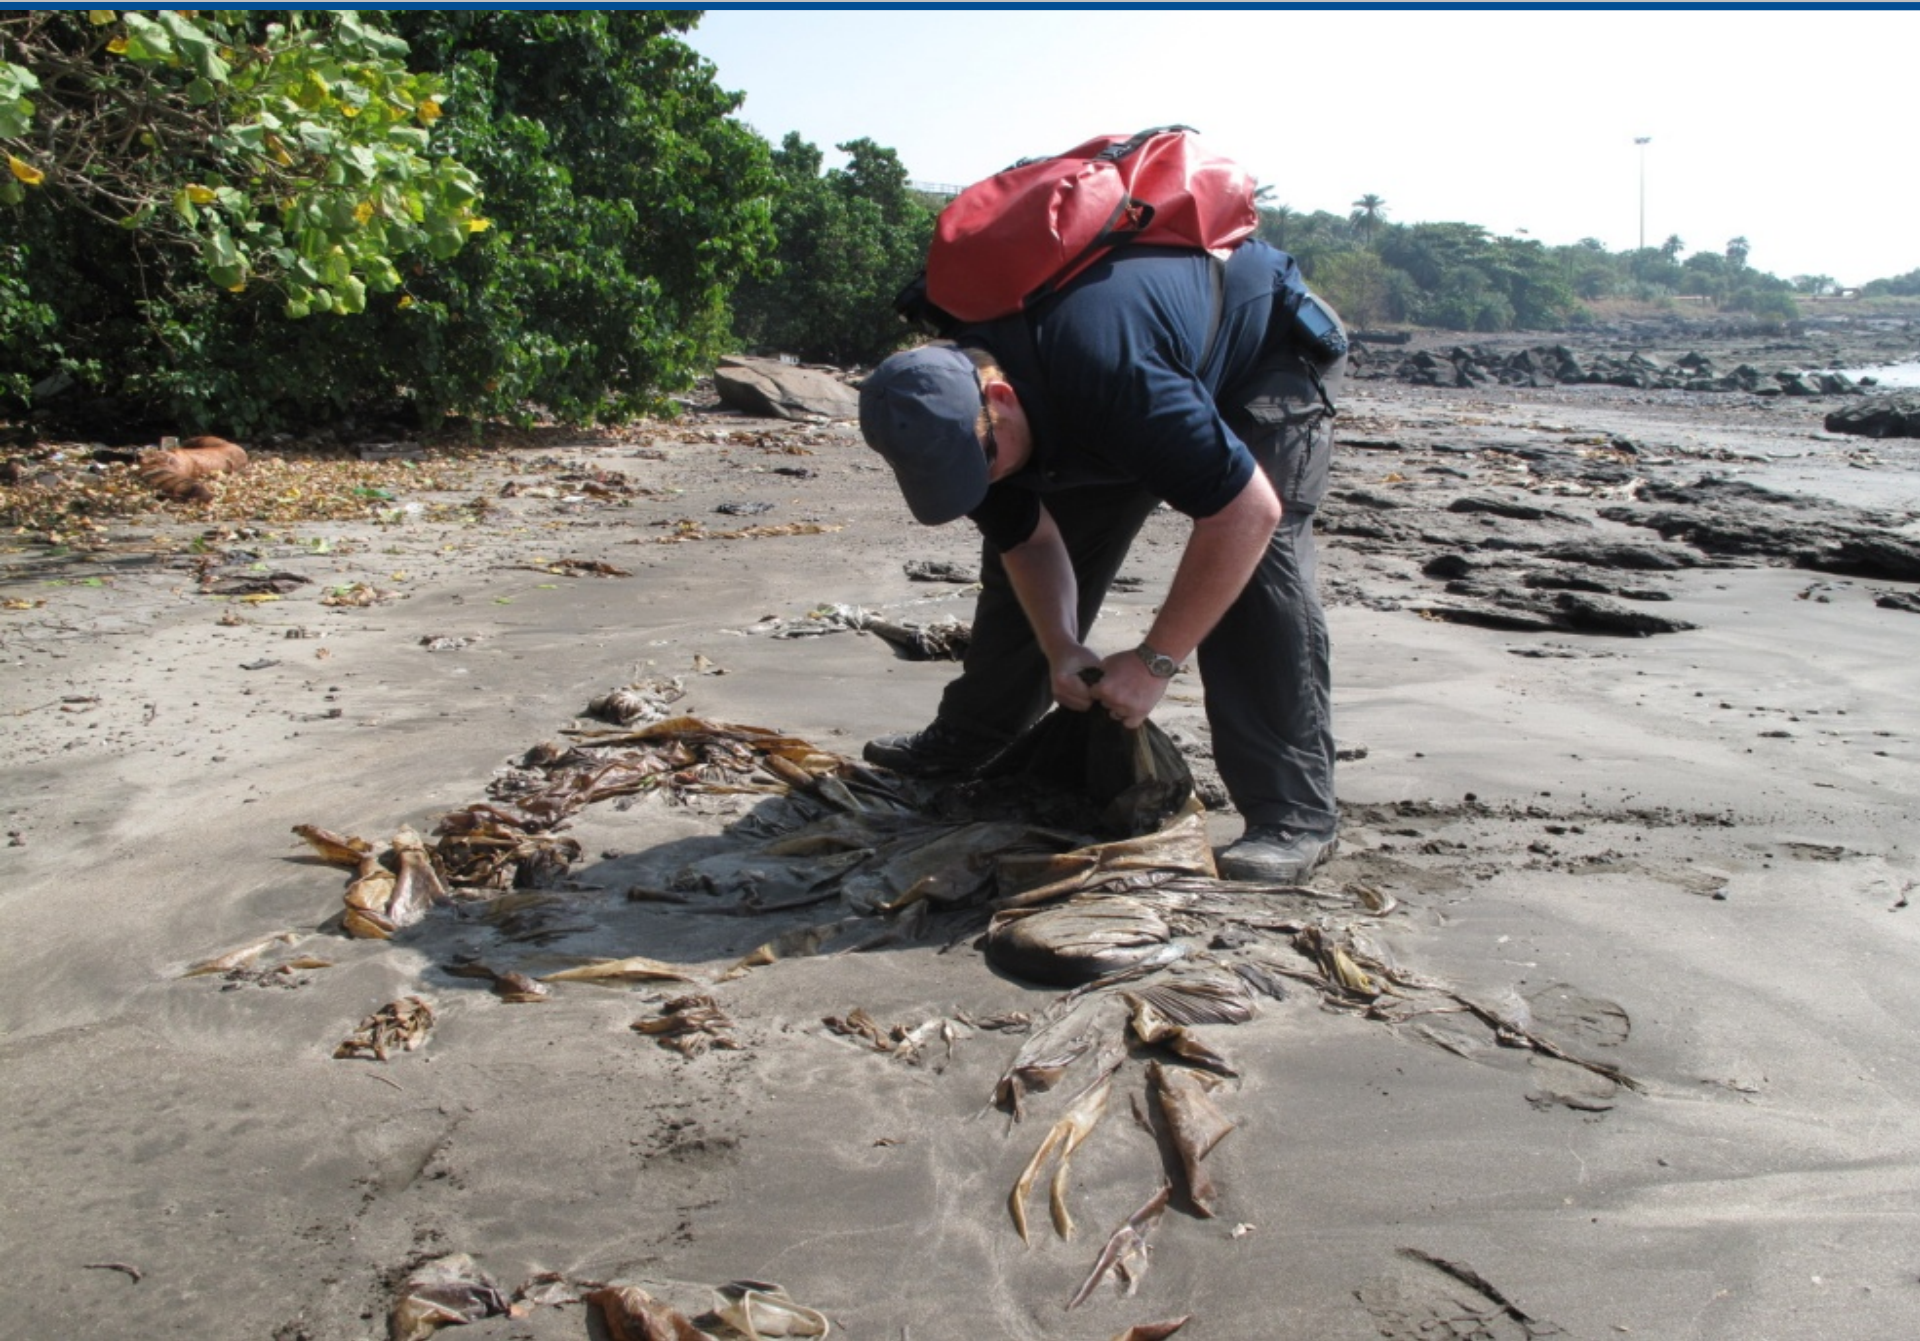
Oil and Cargo ashore together = Hazardous Waste

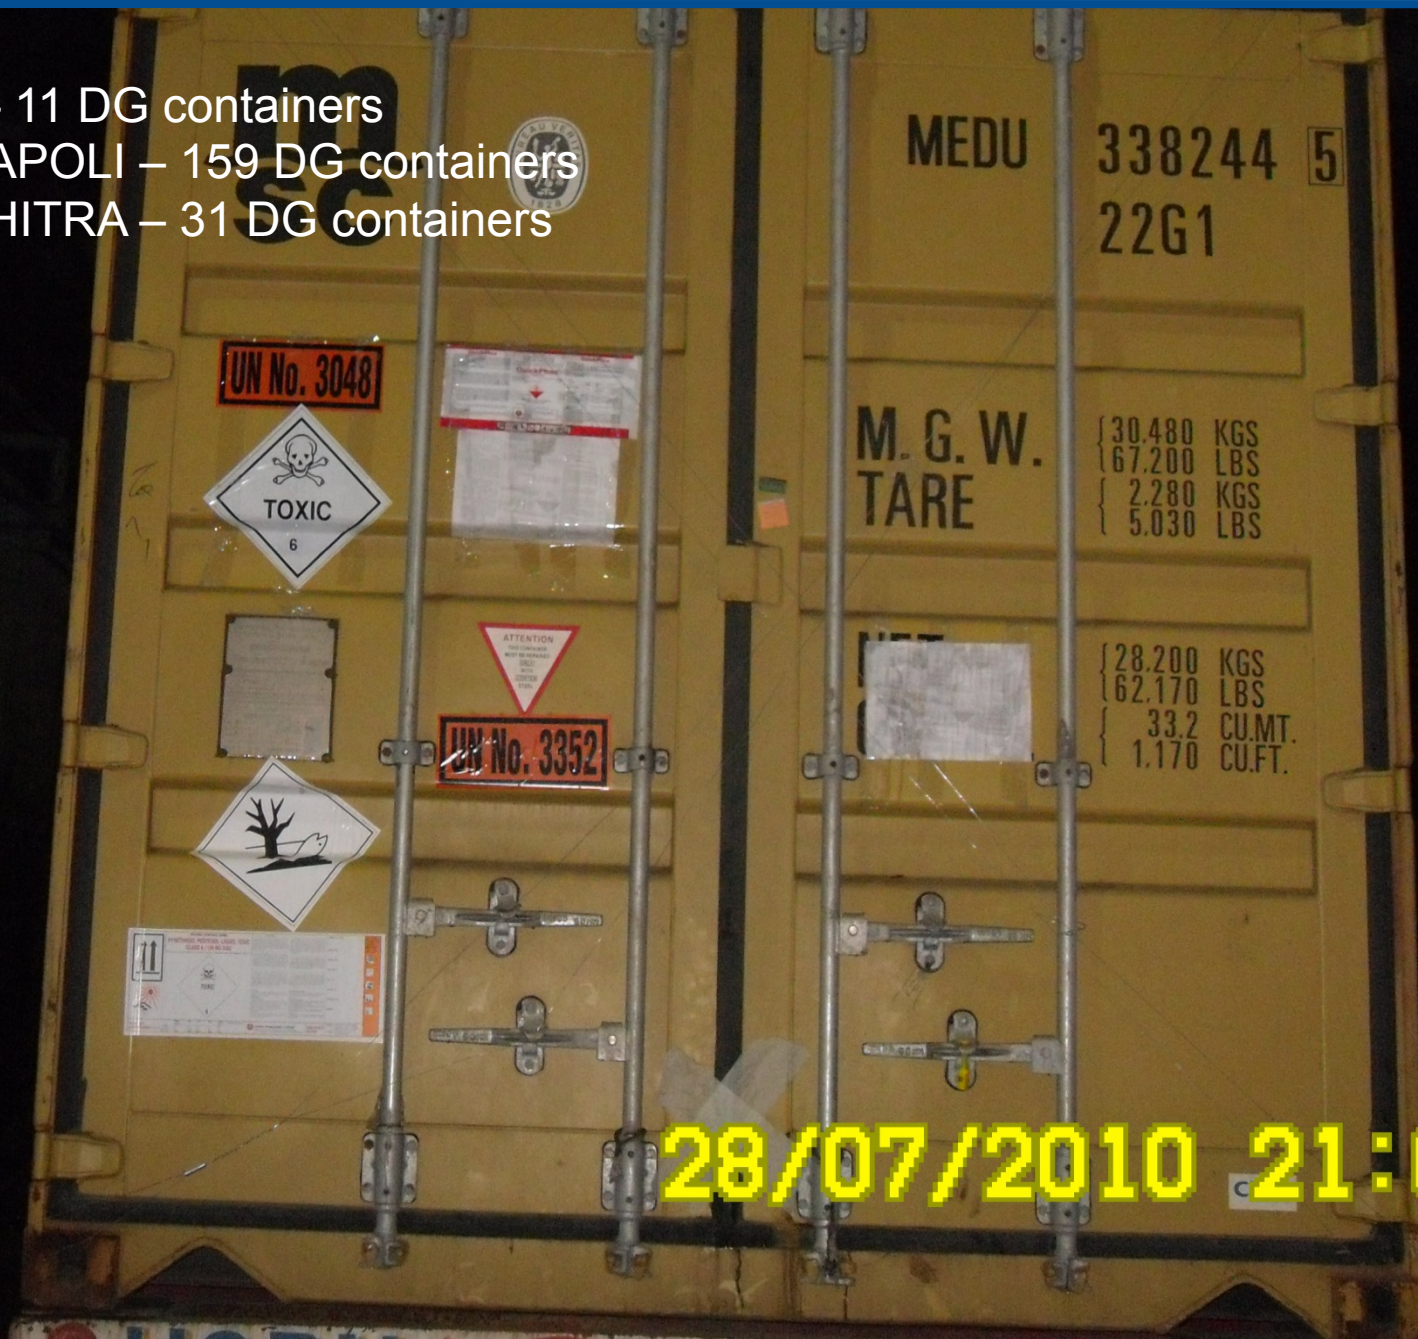
Dangerous Goods on Container Vessels

RENA – 11 DG containers
MSC NAPOLI – 159 DG containers
MSC CHITRA – 31 DG containers

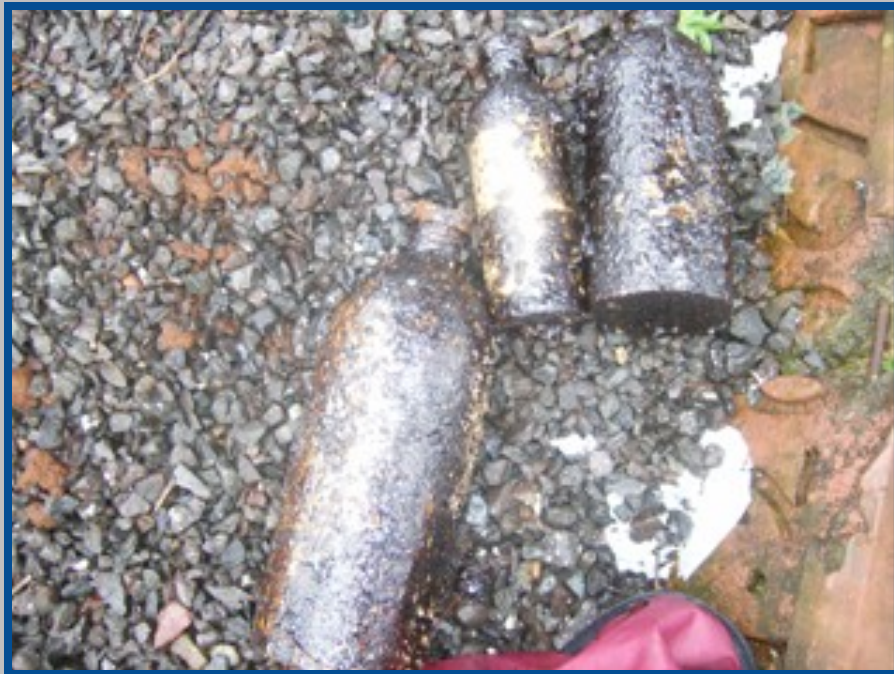
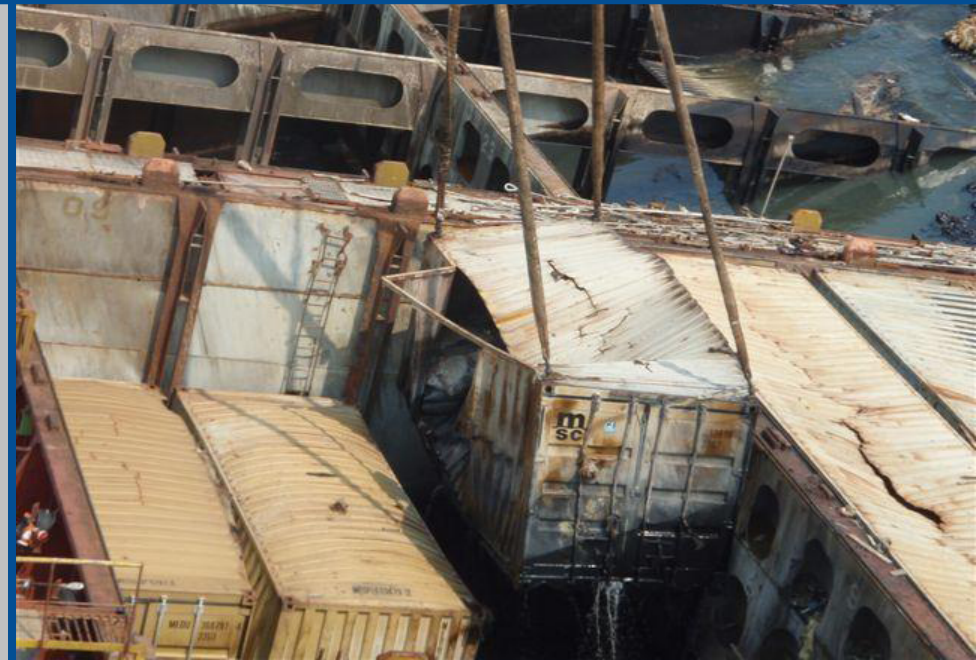
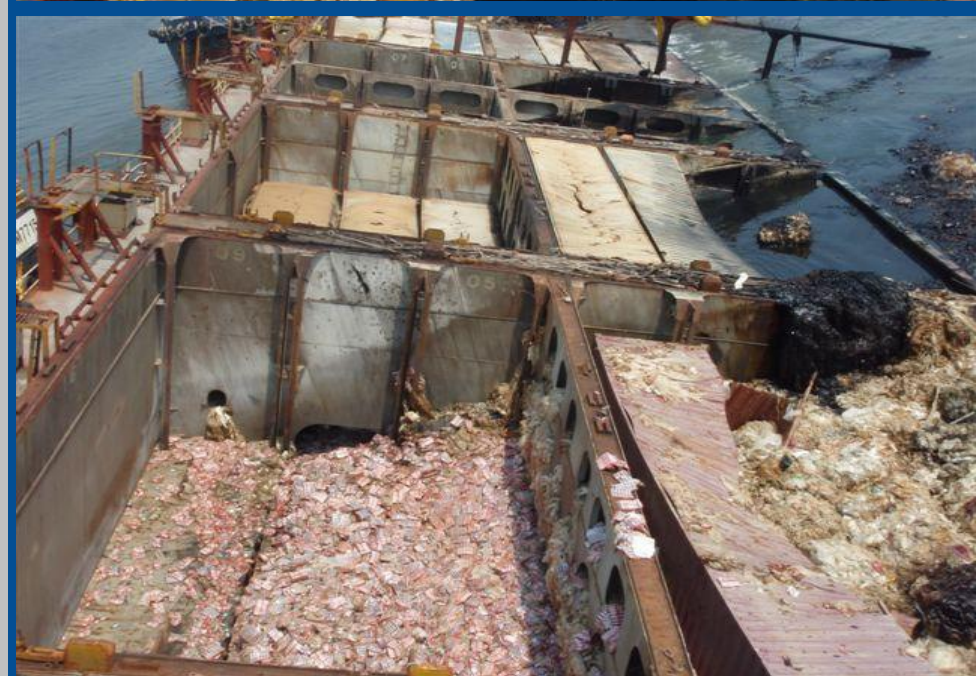
Public Health Issues

- During salvage ops, container with AIP broke open and contents lost to hull/sea
- Contained 4,200kgs AIP – 2,800 x 1.5kg canisters
- Reports received of oiled canisters coming ashore

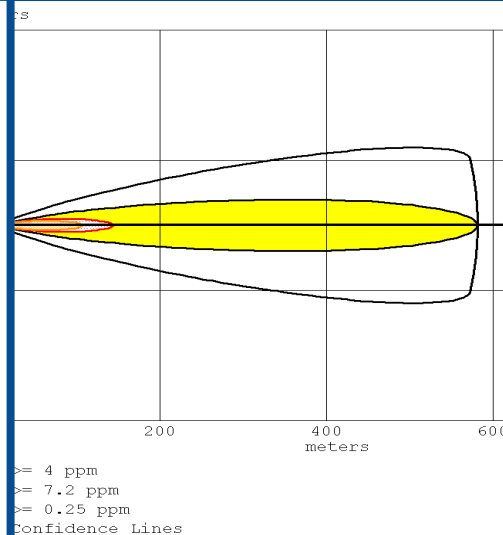
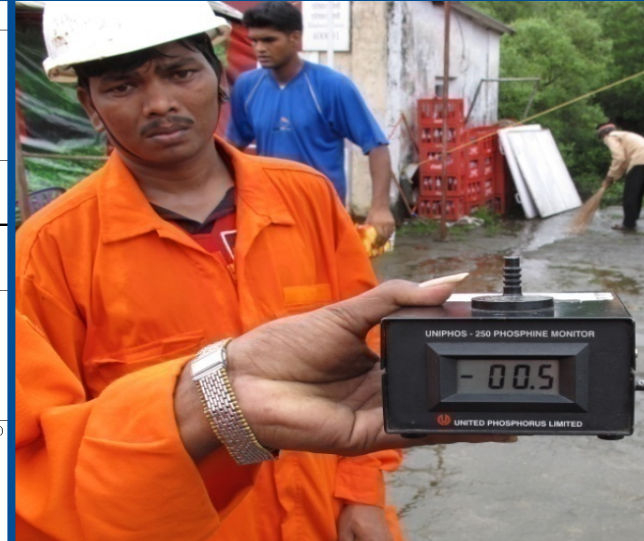
DANGEROUS GOODS RISK ASSESSMENT

- Air modelling done with NCEC – one broken canister and the whole container load; for workers close to wreck (salvors and fishermen), general public (Vessel 500m from Mumbai city), and for shoreline workers
- Full risk assessment written for all Dangerous Goods and the different shoreline clean up techniques used
- Daily sweeps undertaken by MSC and United Phosphorus for all suspicious bottle/canisters – stored in airtight steel box and removed to UP facility for disposal
- Air monitoring undertaken daily before and during clean up at high risk sites

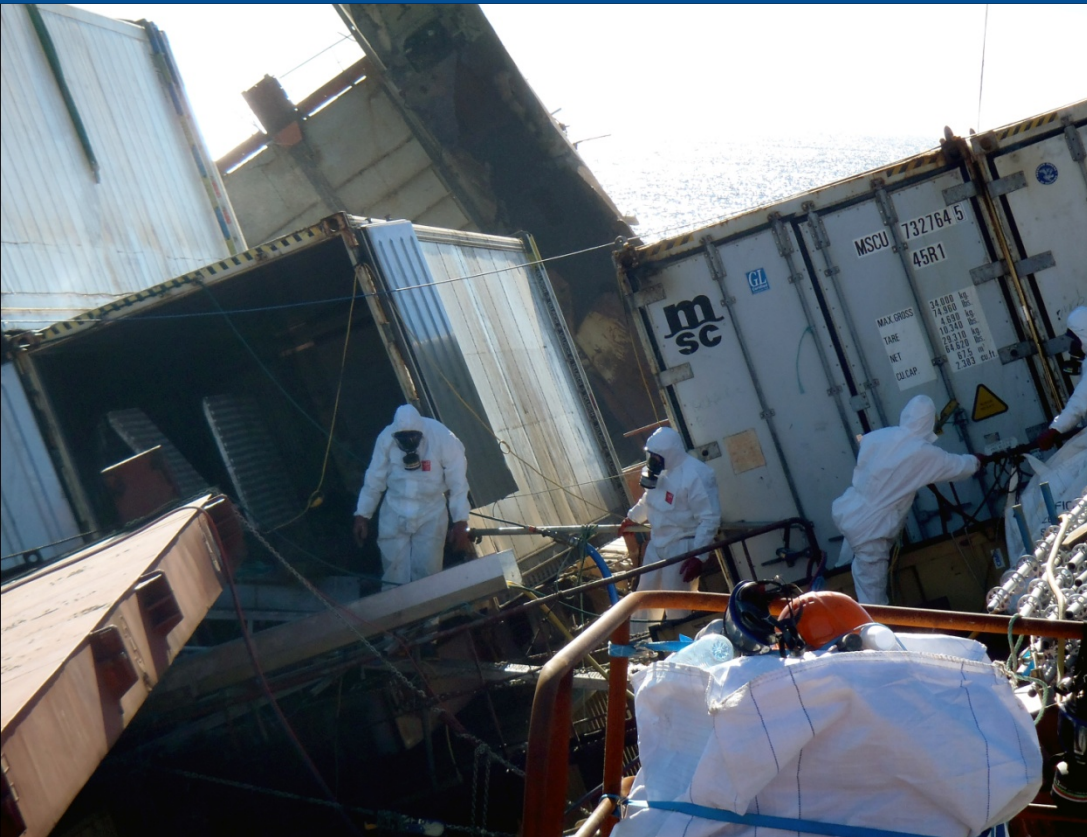
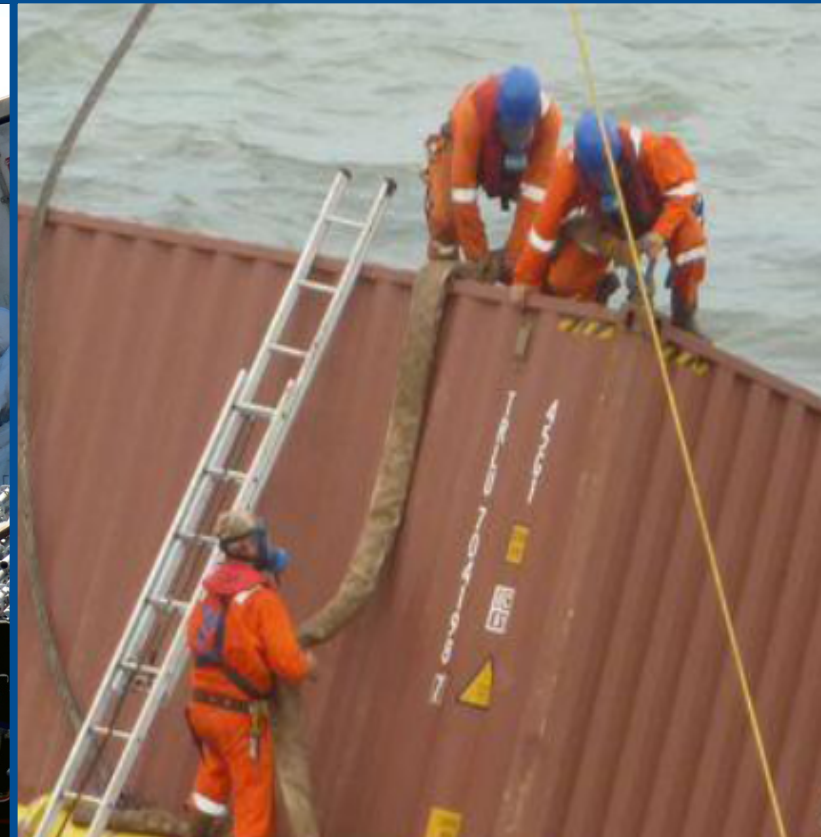
Rotting Cargo

- Salvors reported PH_3 on board MSC CHITRA
- Continual levels; did not fluctuate – not consistent with PH_3
- This out to be H_2S – cargo in containers rotted; exposed to $35^\circ\text{C}+$ temperatures and continually wet (anaerobic conditions)
- Organic and Refrigerated goods rot very quickly in warm & wet condition
- H_2S and PH_3 could not be differentiated by monitoring equipment on board wreck
