Issues from Containership Incidents

Andrew Tucker – Senior Technical Adviser

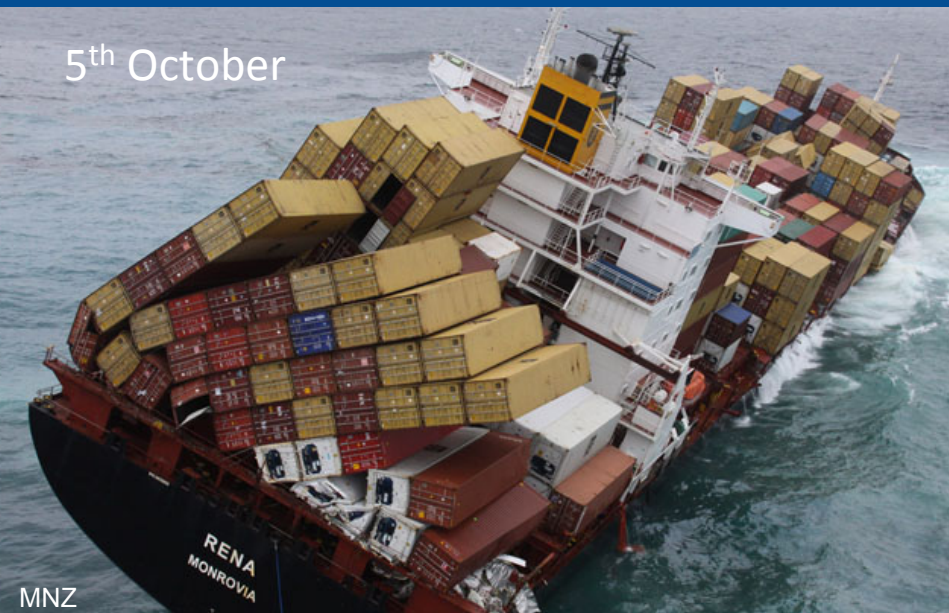
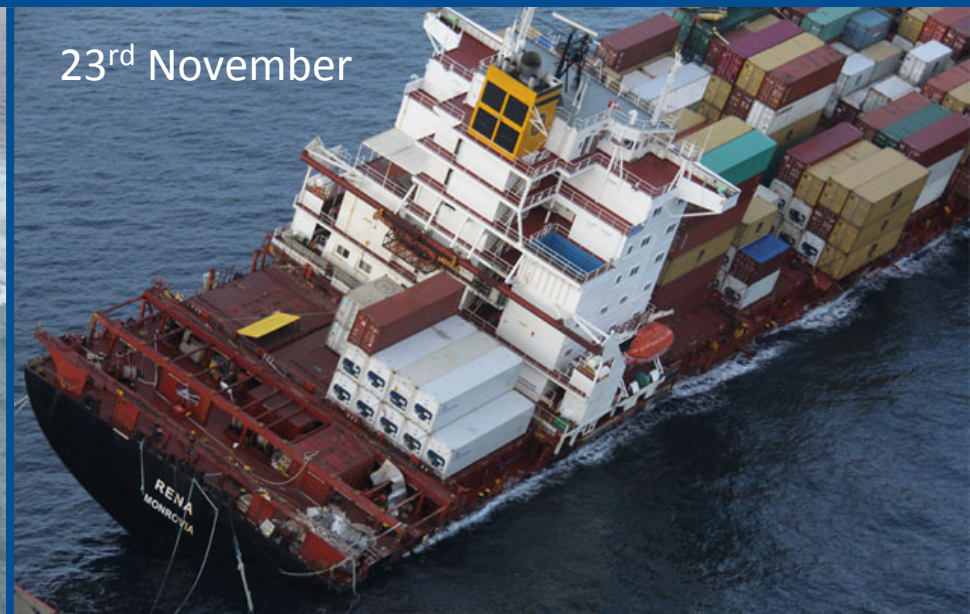
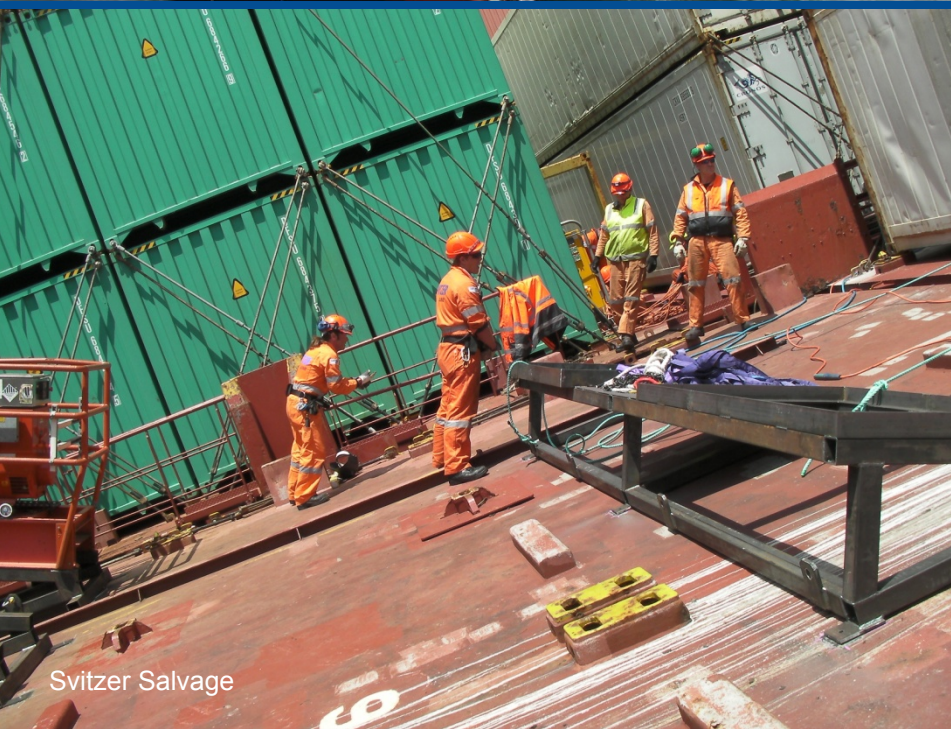
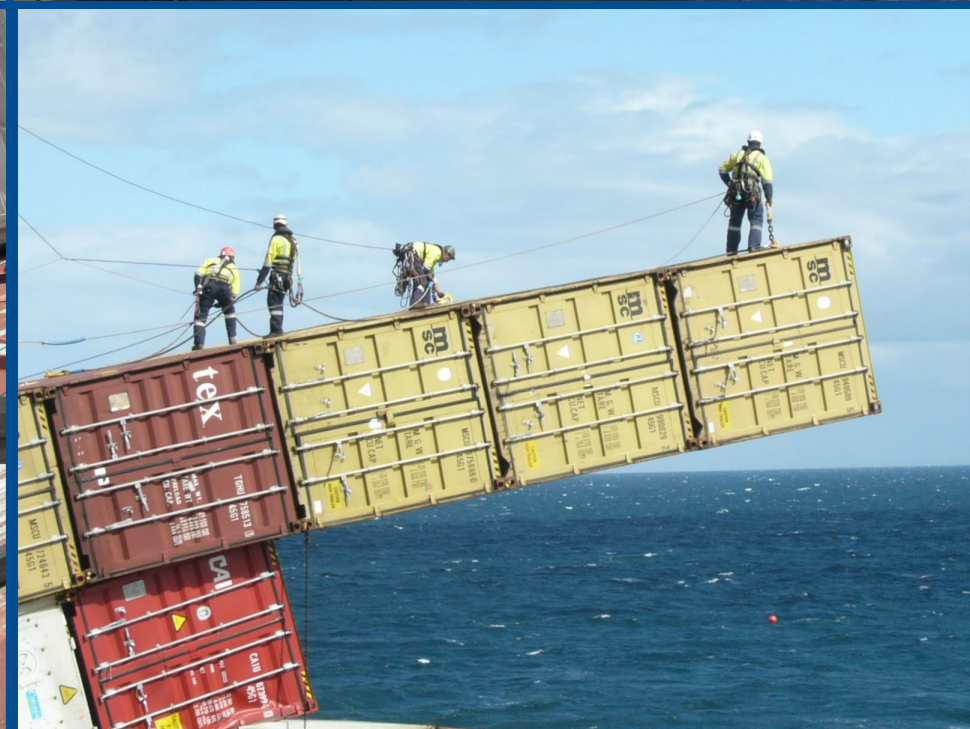
Complexity of Salvage

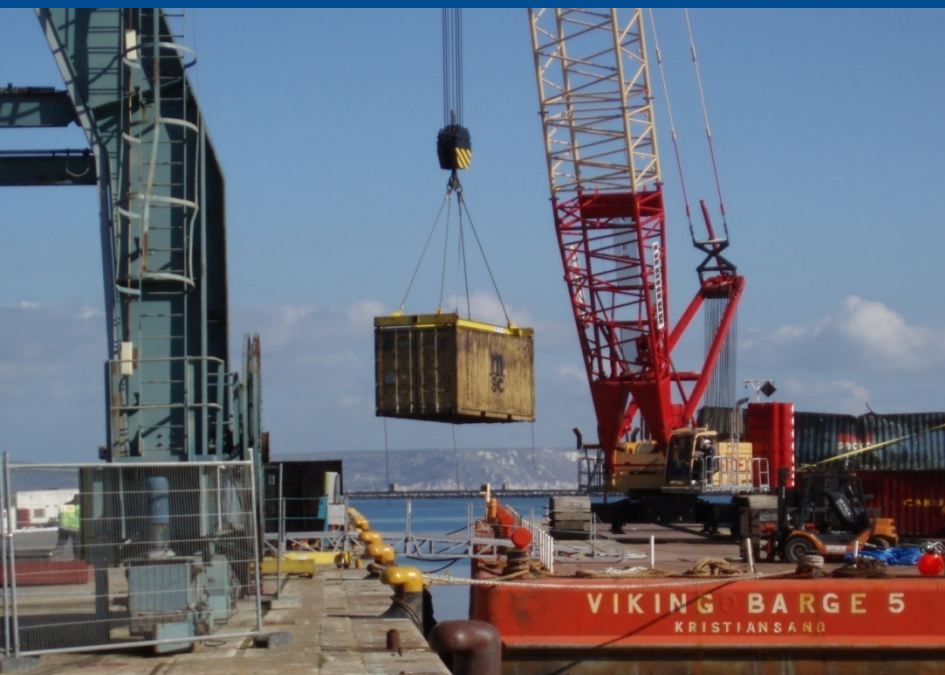
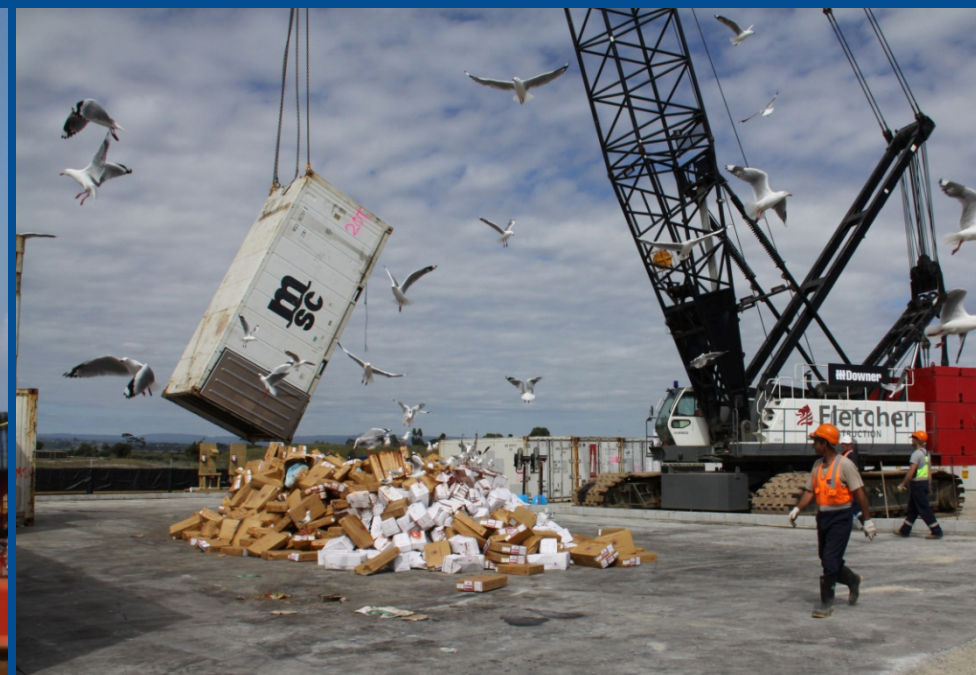
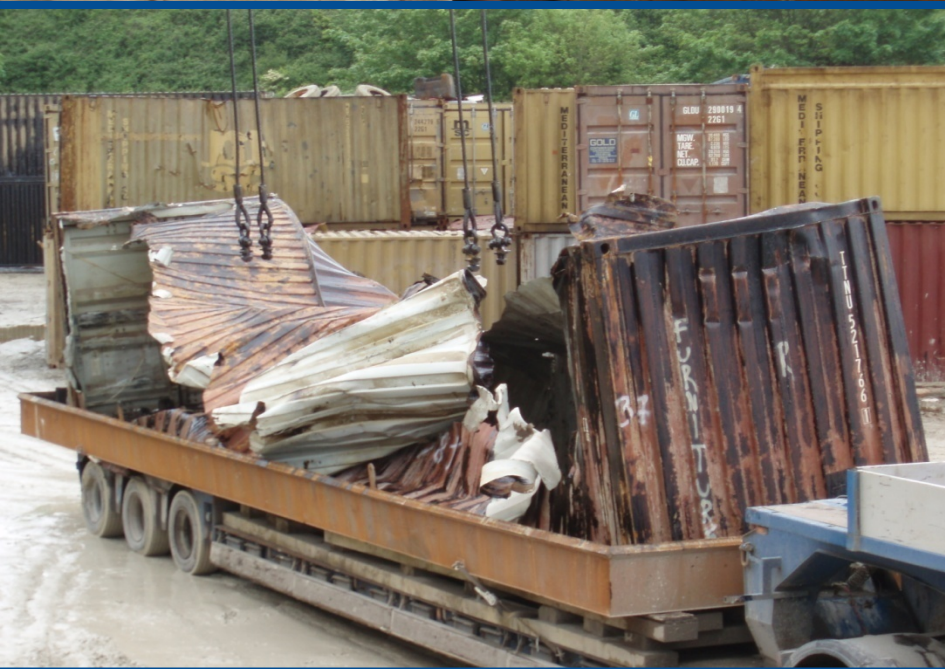
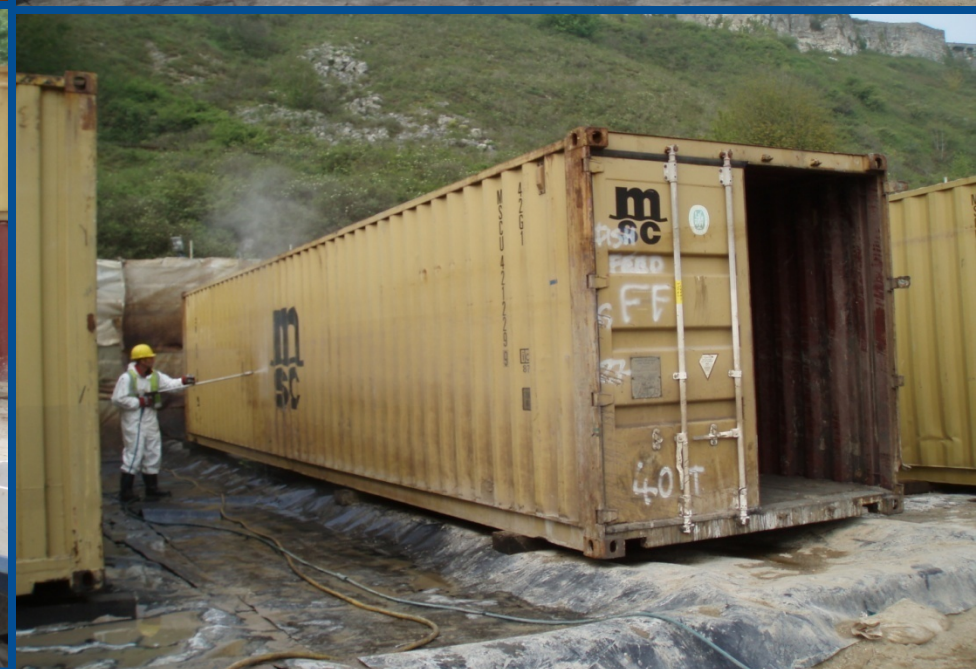
Container Storage, Processing and Disposal

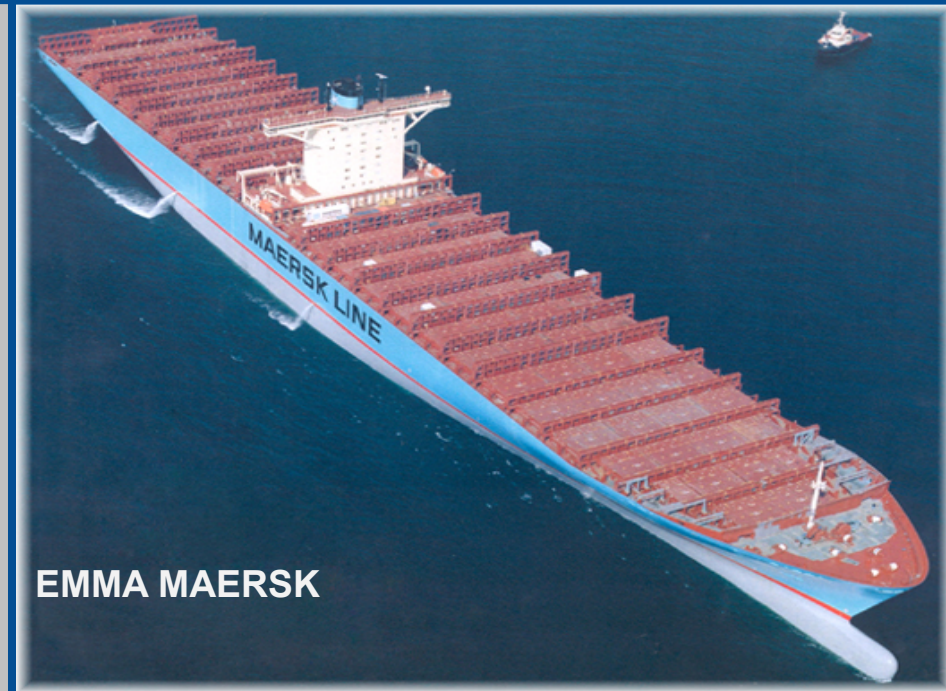
EMMA MAERSK

- Incidents involving container ships have the potential to be complex and long response; incidents so far have involved relatively “small vessels”
- Global trade in containerised goods is growing
- Ever larger vessels; the EMMA MAERSK has capacity of 13,800 TEU & ~17,000 m³ bunkers
- Maersk have recently ordered 10 new “triple E” container vessels – 18,000 TEU & 20,000m³ + bunkers – they will be the worlds largest commercial vessels
- Container vessel incidents tend to happen relatively close to port
- Container Vessels may carry large volumes of HNS/ difficult HNS; potential for public health issues
- Contingency Planning; pre-identify most frequently transported HNS past coastlines as well as temporary storage areas, waste disposal sites, availability of expertise/ equipment, contractors particularly in dealing with the chemical issues
- Entry of HNS Convention!

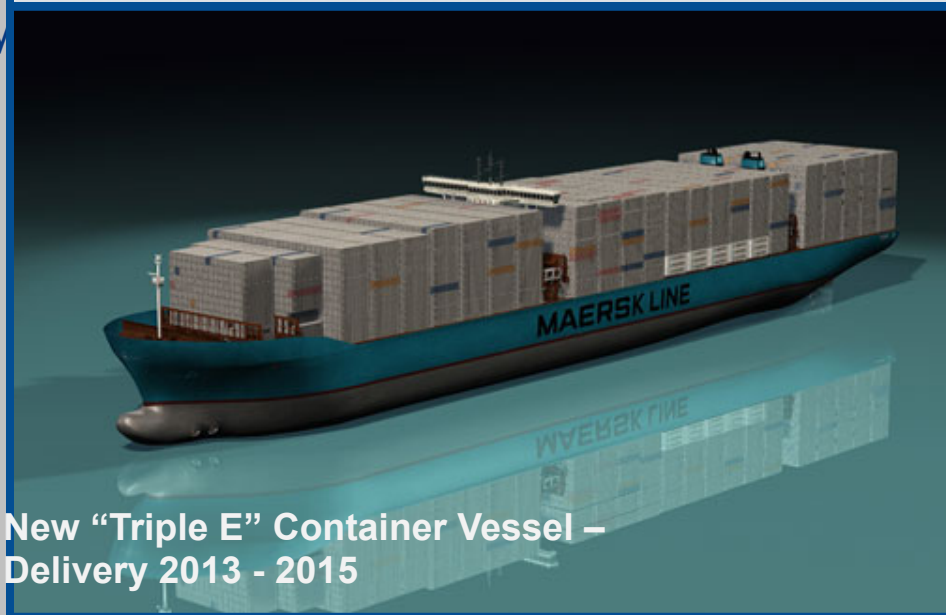
New “Triple E” Container Vessel –
Delivery 2013 - 2015
