NOFO Oil-on-water exercise 2011

Programme for Oil-on-water 2011

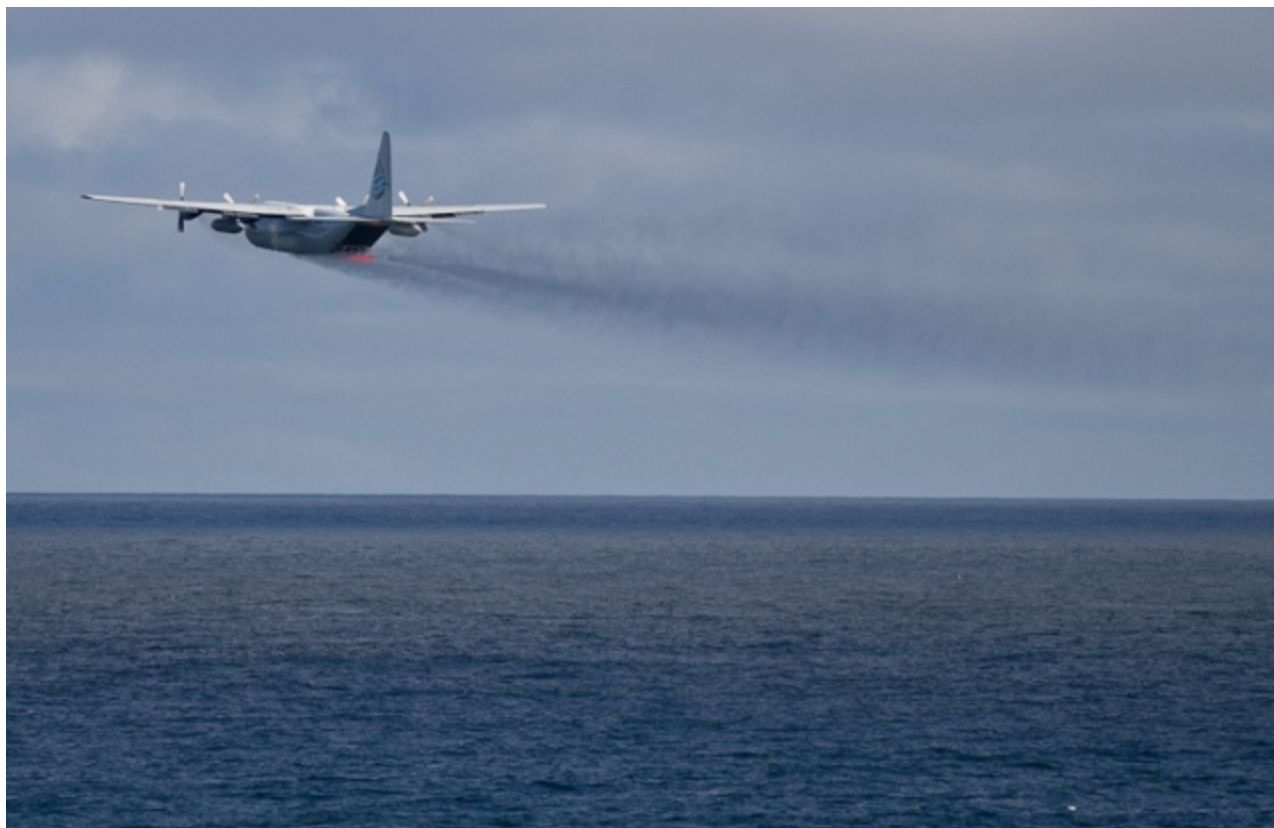
OSRL water application

"Dispersion" using Hercules – together with spotter aircraft

- **LN-TRG guides the Hercules aircraft to the target deployed by the command vessel M/V Normann Jarl.**
- **Collaboration between On-Scene Commander, LN-TRG and OSR Hercules was very good.**
- **The AIS buoys were hit – The test was successful**

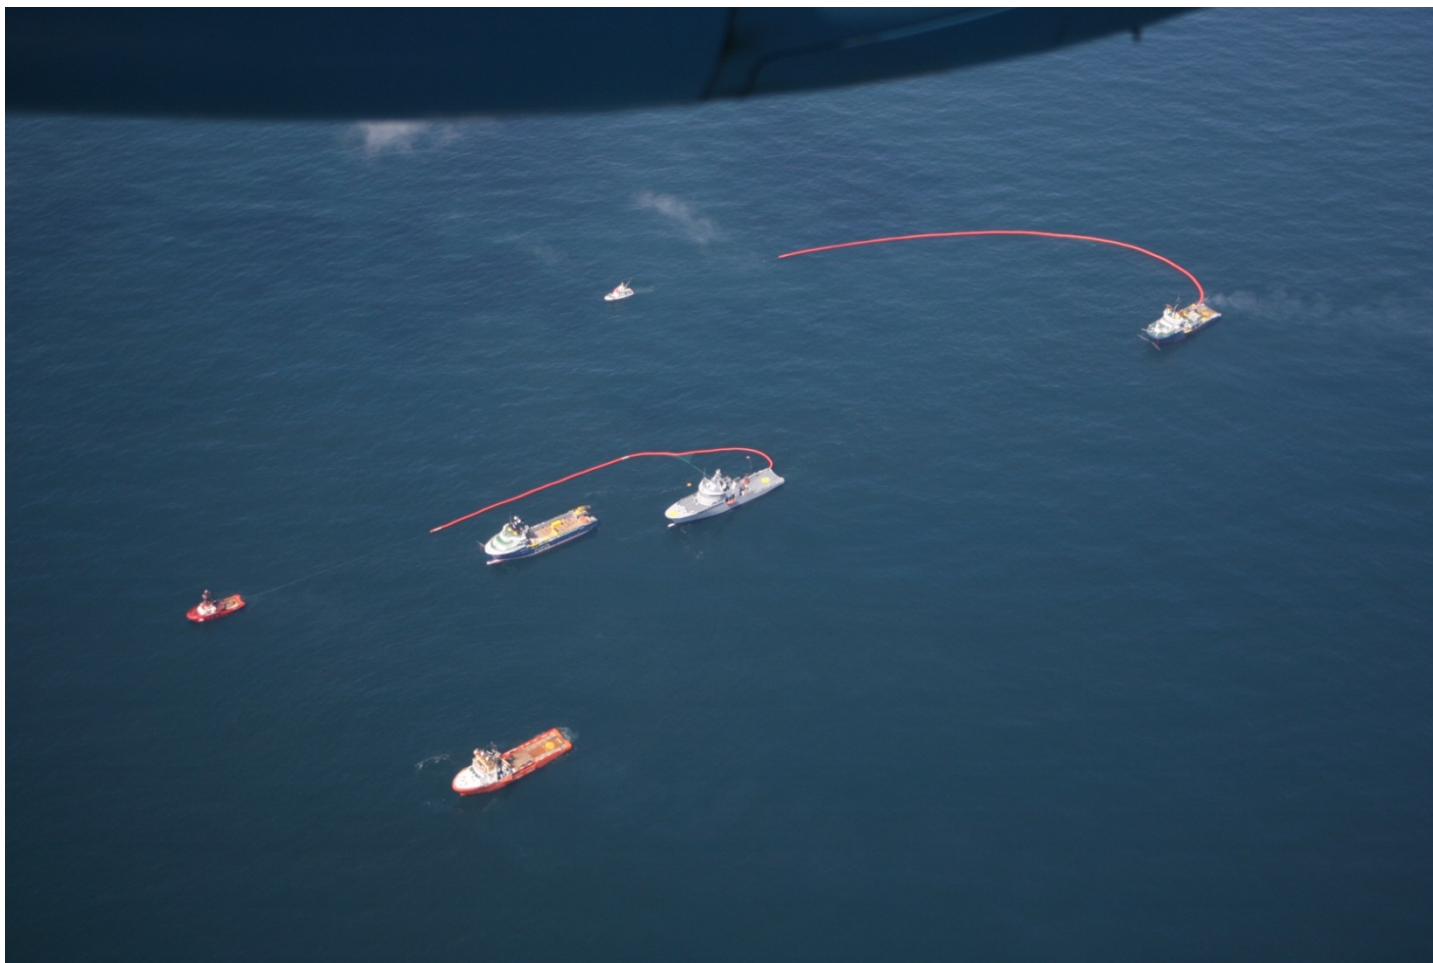
Test with KV Bergen

Recovery using Norèn skimmer on-board KV Bergen

- **Discharge of 20 m³ emulsion into KV Bergen's boom**
- **Recovery using Norèn skimmer – brush and discs**
- **Stril Power recovered emulsion as 2nd system**
- **LN-TRG surveillance – remaining oil was considered not recoverable**
- **Test concluded**

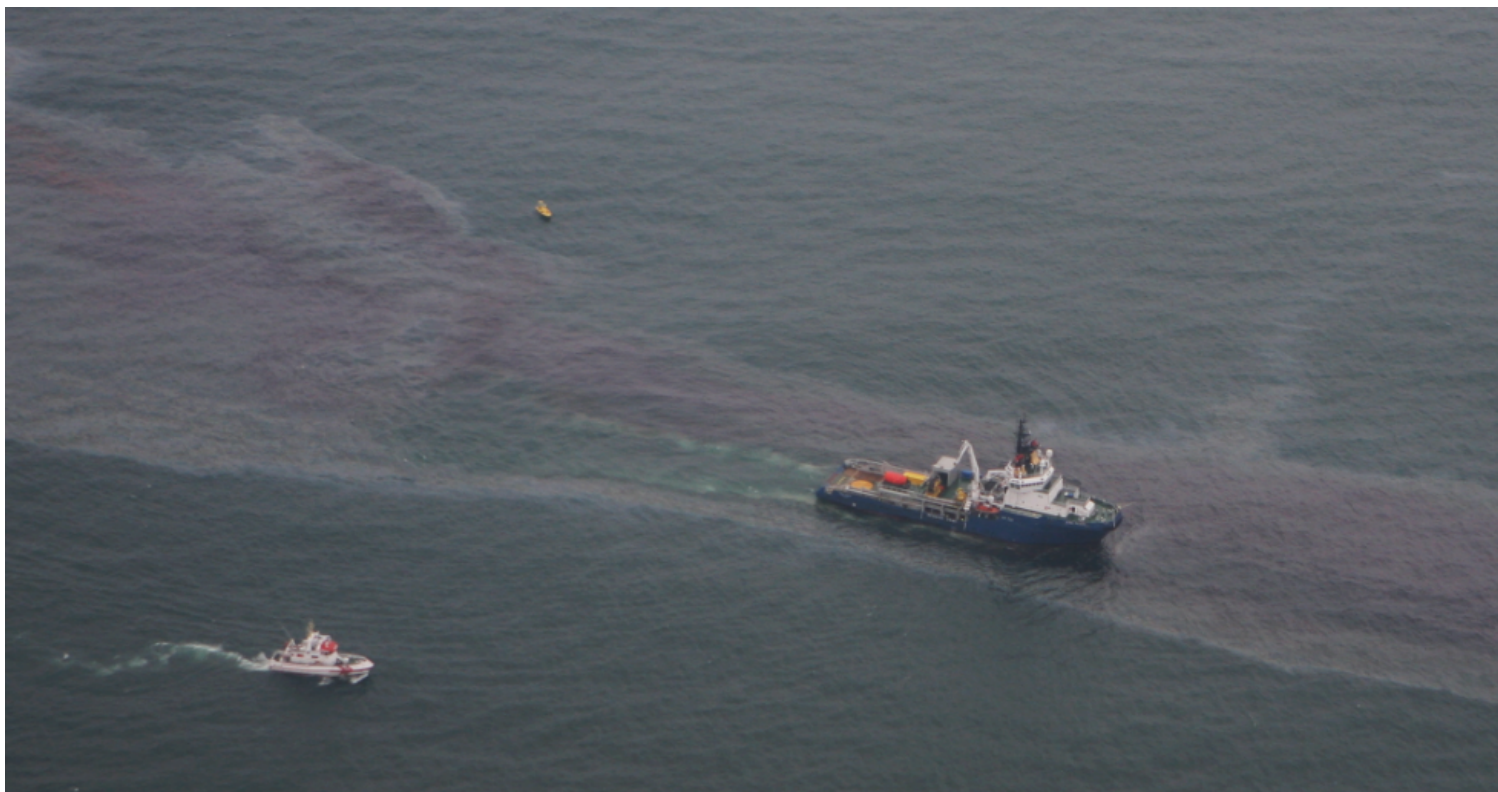
Ship dispersion

Ship dispersant application test

- **Location for planned discharge moved, due to observation of killer whales in the area**
- **M/V Stril Mermaid discharged a total of 30 m³ Balder crude oil**
- **Oseberg SAR Helicopter (LN-OJD) arrived in the area and guided the vessels using IR camera**
- **Swedish Coastguard Vessel KBV 001 Poseidon used own equipment to recover the remaining emulsion. M/V Normand Jarl assisted by use of remote sensing.**
- **No recoverable oil remaining in the sea – exercise termination.**
