## Dealing with HNS from the Napoli

Nick Bailey  
HNS Business Manager  
Braemar Howells Ltd  
UK  
nickbailey@braemarhowells.com

This paper briefly describes how the containers and tank containers were dealt with by Braemar Howells Ltd. in Portland Port after their arrival from the MSC Napoli. It covers in general terms how they were managed on site and then presents three case studies as to how certain of the more hazardous products (both in tanks and containers) were dealt with in order to make them safe for disposal or onward delivery.

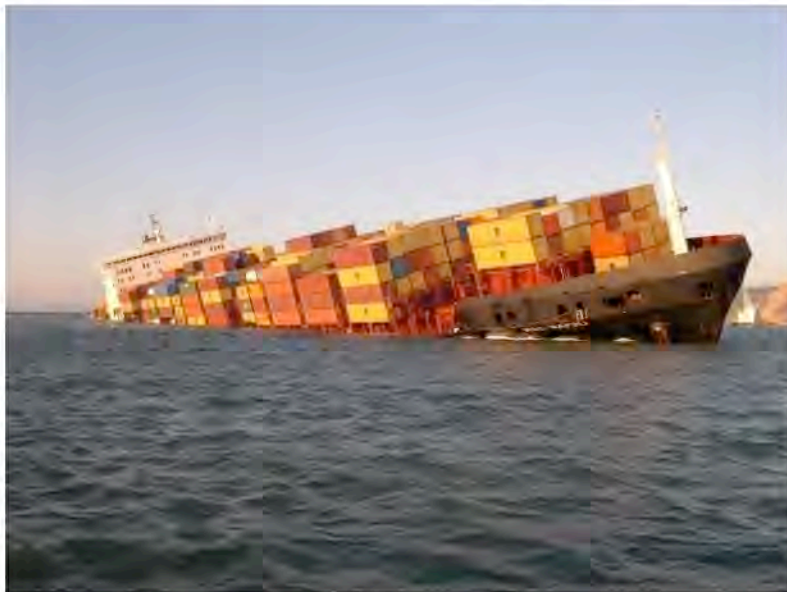
The MSC Napoli, capable of carrying over 4400 'Twenty-foot equivalent units' (TEU's), developed a split in the side and was beached in Branscombe Bay 20<sup>th</sup> January 2007.

Fig.1 MSC Napoli in Branscombe Bay

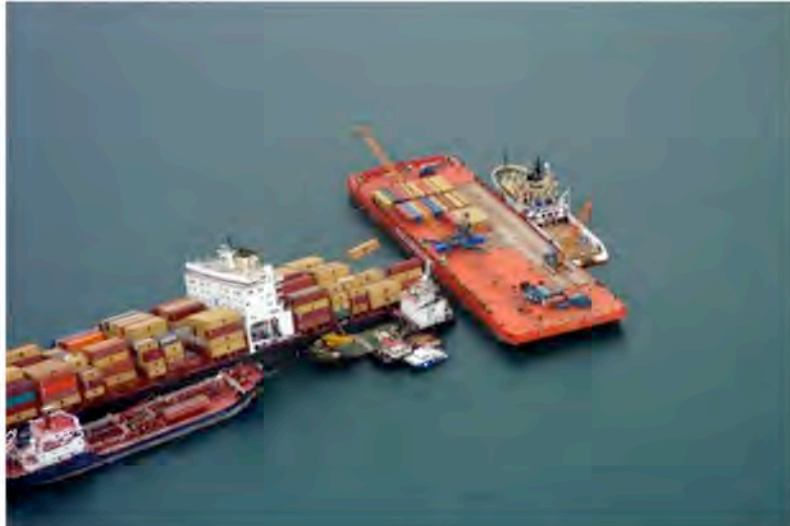
Fig. 2 Containers being loaded to a barge

All of the tanks and containers were offloaded from the Napoli to barges by the salvage company and brought back to Portland Port. After being craned from the barges to the Occasional Coaling Pier (OCP) in Portland the contents of each container were assessed by the loss adjusters. They were then assigned various categories such as re-sale, waste, return/send to consigner/consignee etc. and marked up accordingly. Many of the containers then had to be taken to the washdown facility before being processed or stored in various locations prior to being transported out to their destinations.

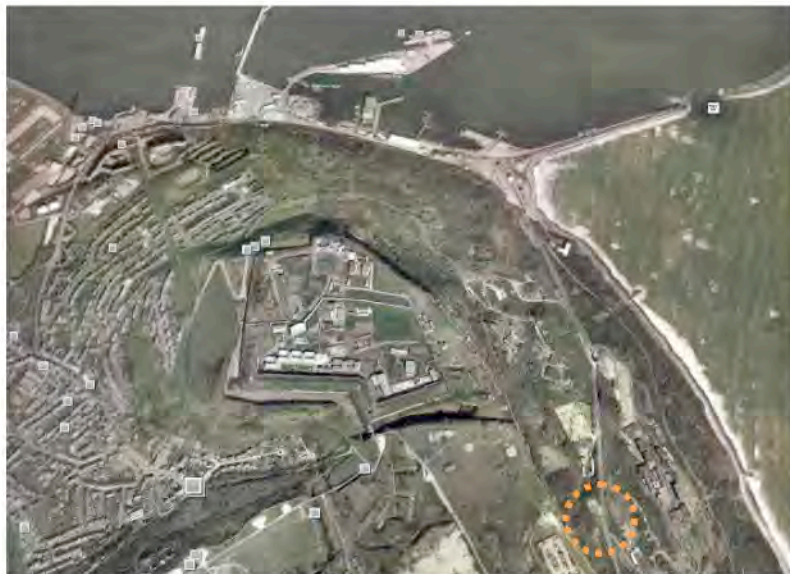
Fig. 3 Area set aside for dealing with HNS containers

The area designated for dealing with the HNS containers (not the tank containers) was known as the burning ground; an area of rough ground well away from the rest of the operation in the port. It was unfortunately difficult to access with large cranes

and other transport and impossible to use fork-lifts. An all terrain telescopic un-loader had to be used for emptying the contents of the containers.

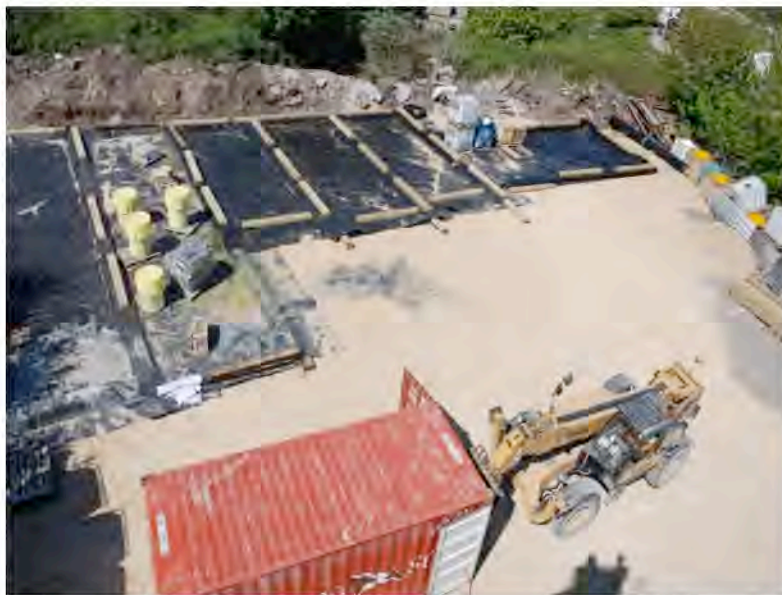
Fig. 4 Bunded areas especially created by Braemar Howells Ltd. for dealing with the HNS from the containers

Several bunded areas were made up for the containers from railway sleepers and heavy duty plastic, in order to contain any potential spills from leaking drums, IBC's and other packages that may be inside. A control area with small office, changing and equipment storage area was set up so that the HNS operation could be largely independent of the rest of the container operations. Containers would be called up, offloaded and dealt with in batches to minimise vehicle and cranes movements to the area.

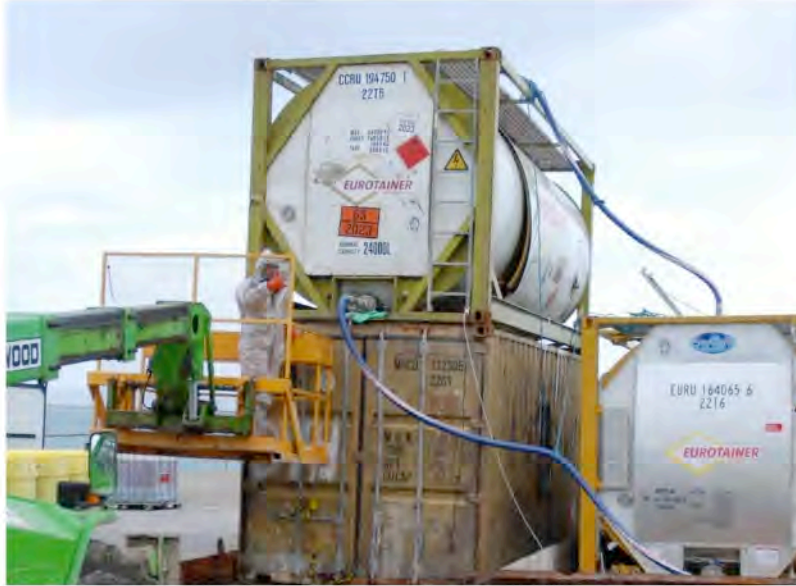
Two tank containers filled with Epichlorohydrin came ashore from the Napoli. At some stage the tanks had become damaged and although not thought to be leaking they were designated unsafe for onward transport. A product transfer had to be carried out to fresh clean tanks that were provided by the product manufacturer / shipper.

Fig. 5. Tank container of Epichlorohydrin being transferred under gravity

Once the PPE and RPE requirements are established and the plan and risk assessments completed, the team can then carry out the necessary work. In this case because of the large volume and particularly hazardous nature of the chemical involved, the plan was reviewed and approved first by both a team of chemists from the product manufacturer and the UK's National Chemical Emergency Centre (NCEC).

New clean hoses and fittings compatible with the product were specified in the plan. Certified clean tank containers purged with nitrogen were provided by the product manufacturer, the tanks and hoses were all earthed and continuity was checked. A gravity transfer of the two tanks was undertaken at night after evacuating the OPC area.

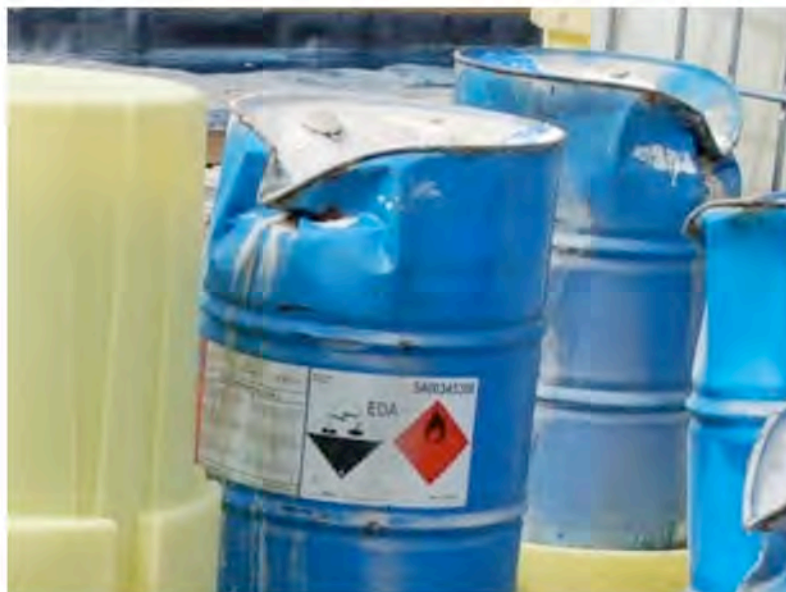
A container filled with drums of Ethylenediamine (EDA). Originally all of the drums were stored neatly on pallets in a double layer in the 20ft ISO container.

Whilst underwater two things occurred, the drums were compressed due to the water pressure from being submerged. In becoming compressed the drums all became dented and this damaged the protective linings inside the drums. This resulted in the chemical attacking the steel and causing almost every drum to leak. The second problem was whilst under water, the pallets and drums started to float around independently inside the container. When the container drained and settled they became wedged and making them difficult to remove.

Fig. 6 Pressure damaged drums of EDA

Once the PPE and RPE requirements are established and the plan and risk assessments completed, the team can then carry out the necessary work. In this case in order to access the drums the container roof had to be removed.

The drums could then be taken out of the container using the tele-handler and placed in the working bund. Teams were then able to package the leaking drums in salvage drums ready for disposal.

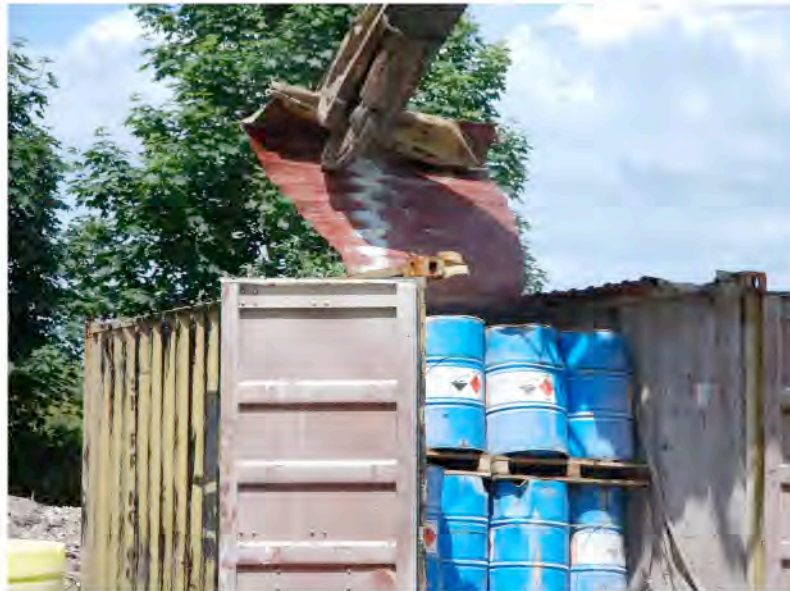
Fig. 7 Lid of the container being removed to access the damaged drums

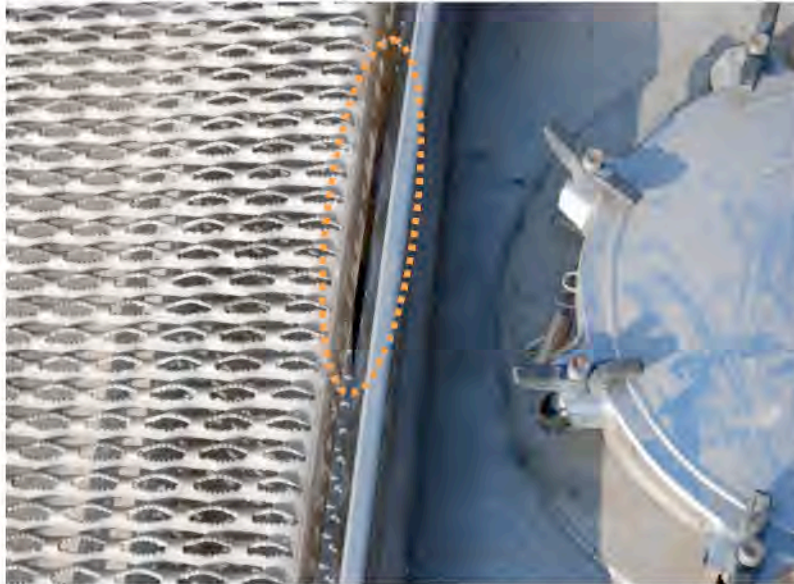
A tank container of methyl methacrylate had been damaged and had a significant split in the top next to the man-lid.

Fig. 8. Damage to Tank Container of Methyl Methacrylate

This would have allowed the inhibitor to have evaporated during storage on OCP. The product was also contaminated with sea water and it was necessary to add a final 'killer' inhibitor to render the product harmless and unable to polymerise.

Once the PPE and RPE requirements are established and the plan and risk assessments completed, the team can then carry out the necessary work. In this case the tank and hoses were connected up and earthed. Several hundred litres were then drained off from the bottom valve into a suitable container and inhibitor added through the man-lid to render the product harmless.

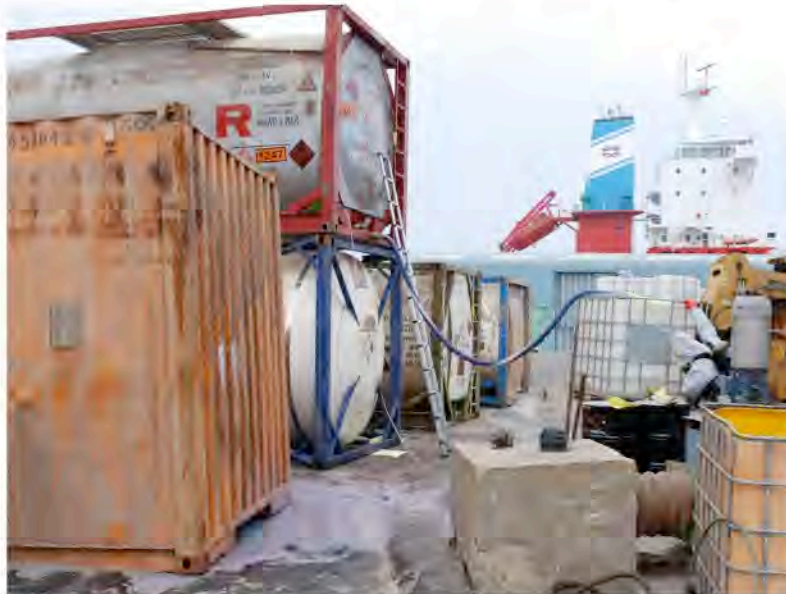
Fig. 9 Preparing to Add Inhibitor to a Tank Container of Methyl Methacrylate by Bleeding off some of the contents to an IBC.
