Case History: Spill Response for the 2014 Somerset Level Floods

Hannah Goddard
Oil Spill Response Ltd
hannahgoddard@oilspillresponse.com

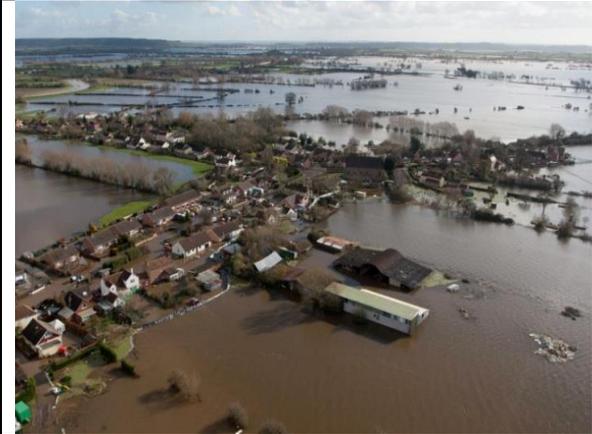
Extent of flooding in Somerset (source: BBC)

During the winter of 2013/2014, the UK suffered a succession of major storms with unprecedented volumes of rainfall and high winds. The low lying area of the Somerset Levels in the South West, reliant upon an aging network of pumping stations and man made drainage channels, was soon overcome by the sheer volume of water. In early 2014 the Environment Agency estimated there were over 100million cubic meters of floodwater covering an area of 65 square kilometres, resulting in extensive flooding affecting over 600 houses and 17,000 acres of agricultural land.

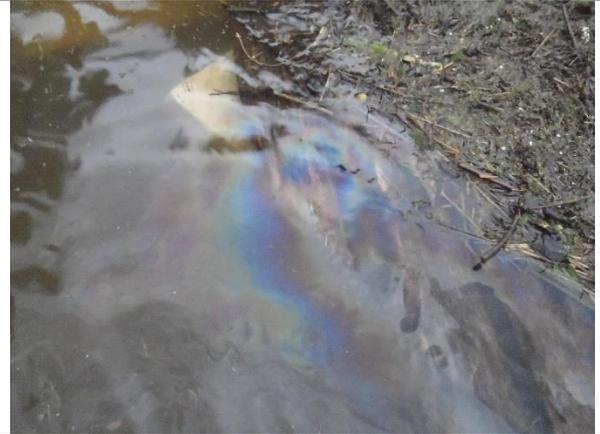
Kerosene sheen present in floodwaters

Domestic heating oil systems use kerosene, which once spilled spread quickly in the floodwaters making a thin sheen. Much product was expected to have evaporated or been dispersed into the water, sheen was still reported and the remaining tanks were causing an issue to the response effort as a whole.

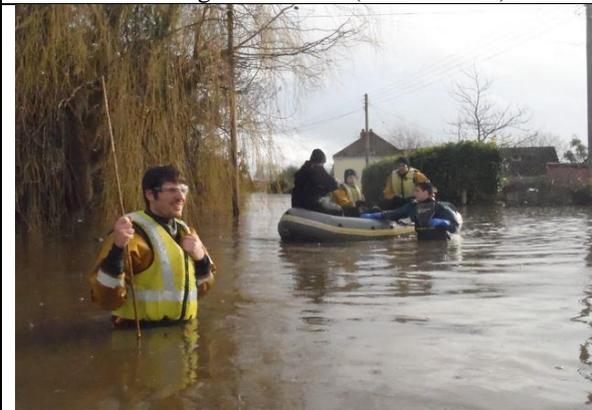
Response effort (OSRL with other agencies)

The use of small boats also had its risks, an inflatable boat and outboard engine significantly improved access and the speed of response but care also had to be taken to avoid underwater obstructions and debris. The propeller also posed a hazard when used near other responders in the water. A combination of outboard engine and paddles were used to access difficult sites.

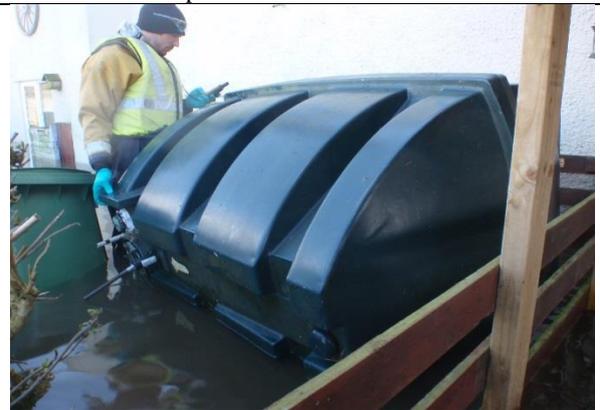
Identifying and mapping affected tanks

OSRL's first objective was to survey and map the extent of the pollution and damage to tanks. This was done using GPS tracks, photos and verbal reports. Location mapping along with photos of affected tanks were produced visually on a kmz, able to be viewed in Google Earth. This gave an excellent visual representation of the operation. Any tanks found to be still leaking or could cause further spillage were dealt with. The use of sealant putty, was an initial fix on open pipes or ruptures links. Any upturned and free-floating tanks were righted and made secure.

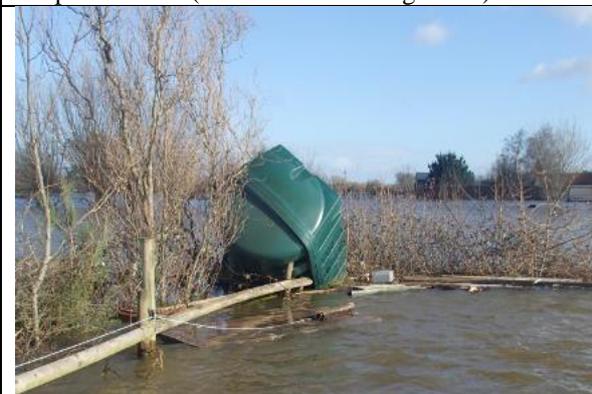
Loose stranded tanks

Due to the remote nature of many villages on the Somerset Levels, private homes are powered by domestic oil heating systems, comprising of a large (typically 1-2,000l) storage tank in each property's ground. By January many of these tanks, often re-filled for the start of winter, were now only partially full. When the floodwaters hit, many floated free, rupturing supply pipes and hoses to houses. Some of these tanks upturned, spilling their contents while others, completely free, drifted some distance away from homes.

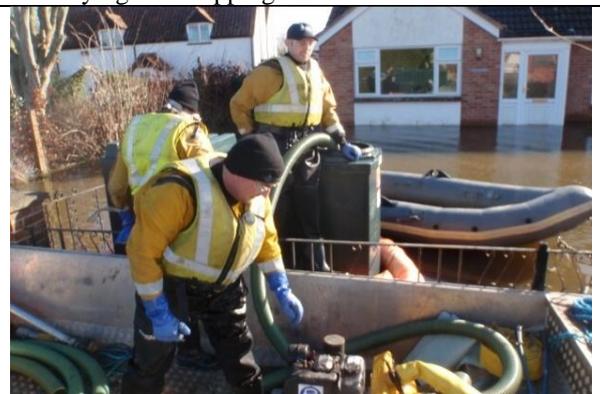
Pumping out stricken tanks

Once all tanks had been identified and temporarily made secure, the decision was made to transfer all remaining product in the tanks into more secure storage. Any floating tanks were towed into a single area, which was bunded with sorbent then pumped into storage IBCs. Those tanks that could not be moved were emptied in-situ. Records were kept of volumes of product and the original location of the tanks, some were not identifiable as they were not marked and had drifted away from homes. These records were passed onto the EA.

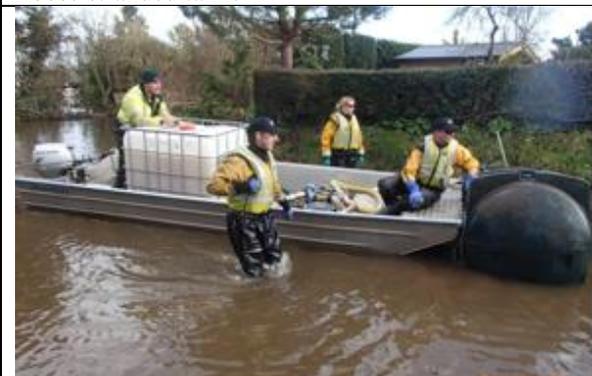
Transportation of tanks and recovered product (working with EA boat)

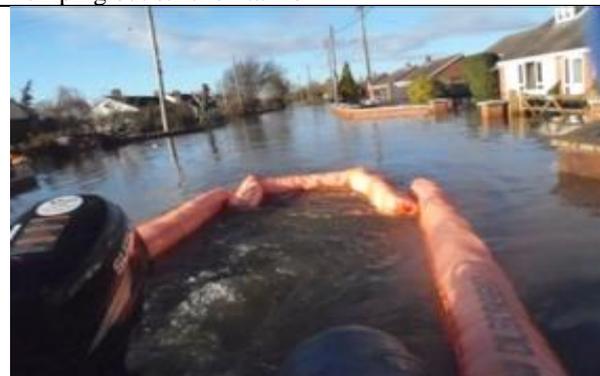
Assisted dispersion of surface sheen

Any remaining sheen on the water, often close by to breached tanks, was treated where possible. Assisted natural dispersion through propeller washing into a sorbent bund was found to be the most effective. Little else could be done at this stage. Continued rain, wind and water movement was also assisting natural dispersion.
