Interspill 2022

Use of on board RPAS during oil spill response: recent evidence reinforces the benefits of RPAS to support response operations

Extended abstract by the European Maritime Safety Agency (EMSA)

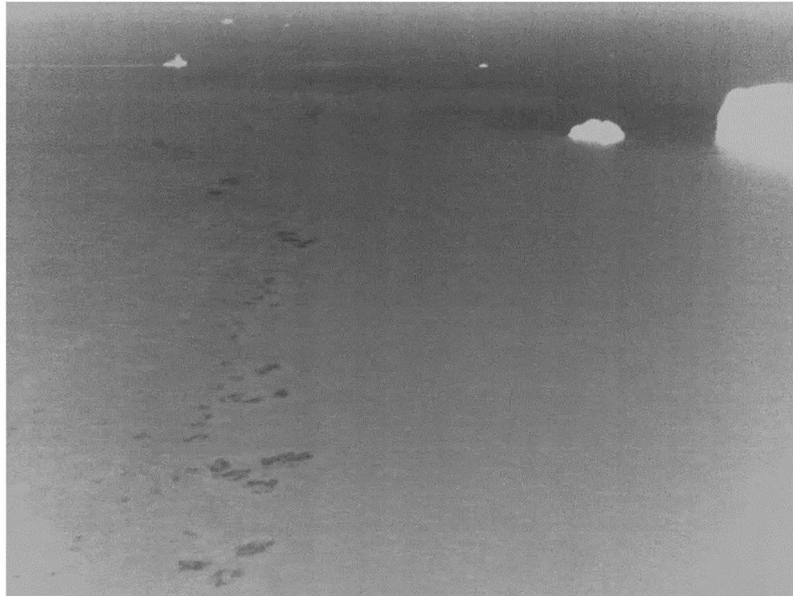
Figure 1: Trail of oil from the location where the vessel sank

The RPAS was useful at the start of the operation to locate the position of the wreck and identify where the oil was surfacing. This was particularly important given that sea conditions and currents were displacing the oil considerably. The RPAS conducted a general surveillance flight initially, enabling the response team on board to visualize the thick brown oil rising to the surface and how the oil became thinner as it spread out from the source. The RPAS footage showed lines of oil in the water moving away from the main location where oil was surfacing.

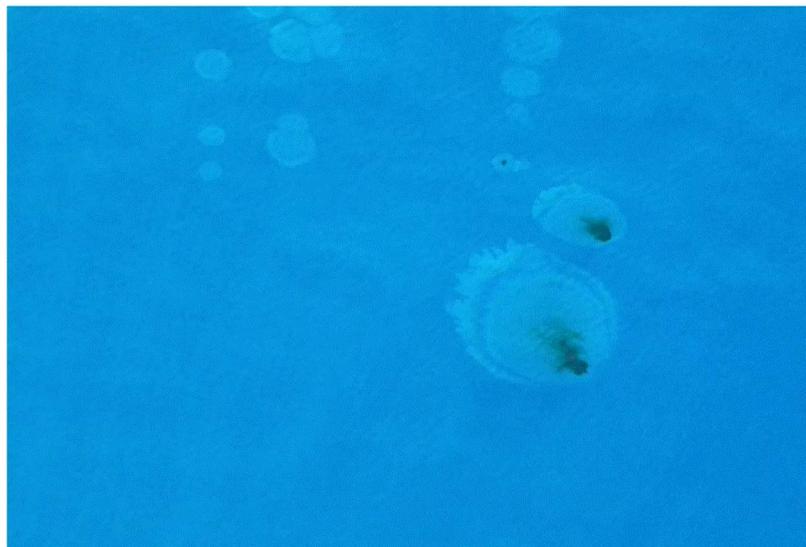
Figure 2: Pollution surfacing and spreading

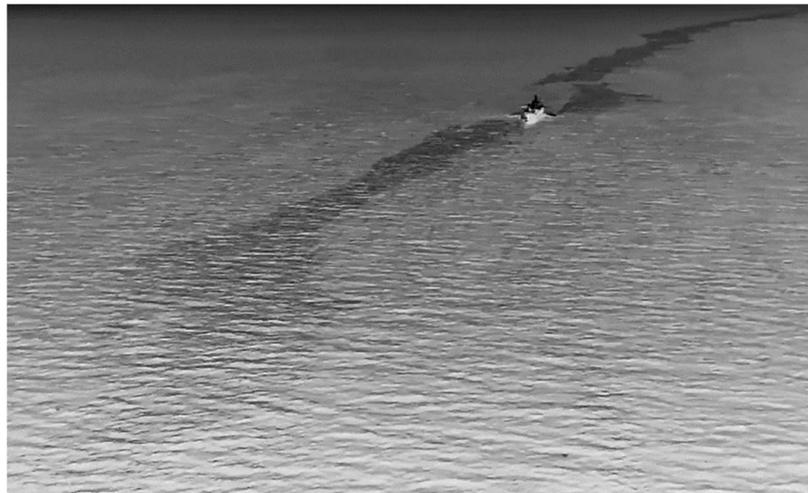
Figure 3: The RPAS was used to check the positioning of the Aktea

The information provided by the RPAS was used to direct the OSRV to the source of the oil, not only by providing coordinates on the map, but also by physically hovering over the location to mark an area. This was an advantage in the open sea, given that it can be difficult for the vessel to maintain position in rough weather conditions. The RPAS was also used to monitor the activities of the Aktea, for example to check behind the vessel to verify that the oil was being collected, and that the equipment was operating well.

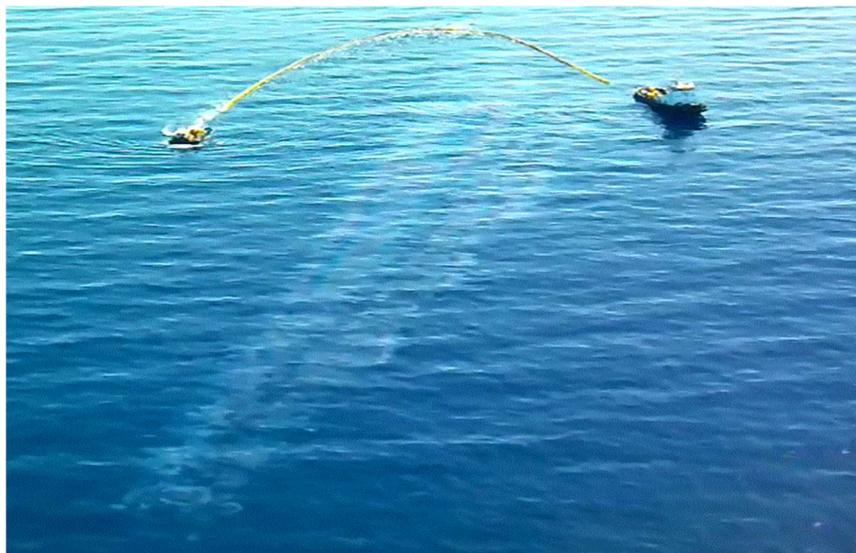
Figure 4: Other vessels involved in clean-up operations

The RPAS footage also provided strategic information to the overall response operation, and to support activities of other vessels in the area.

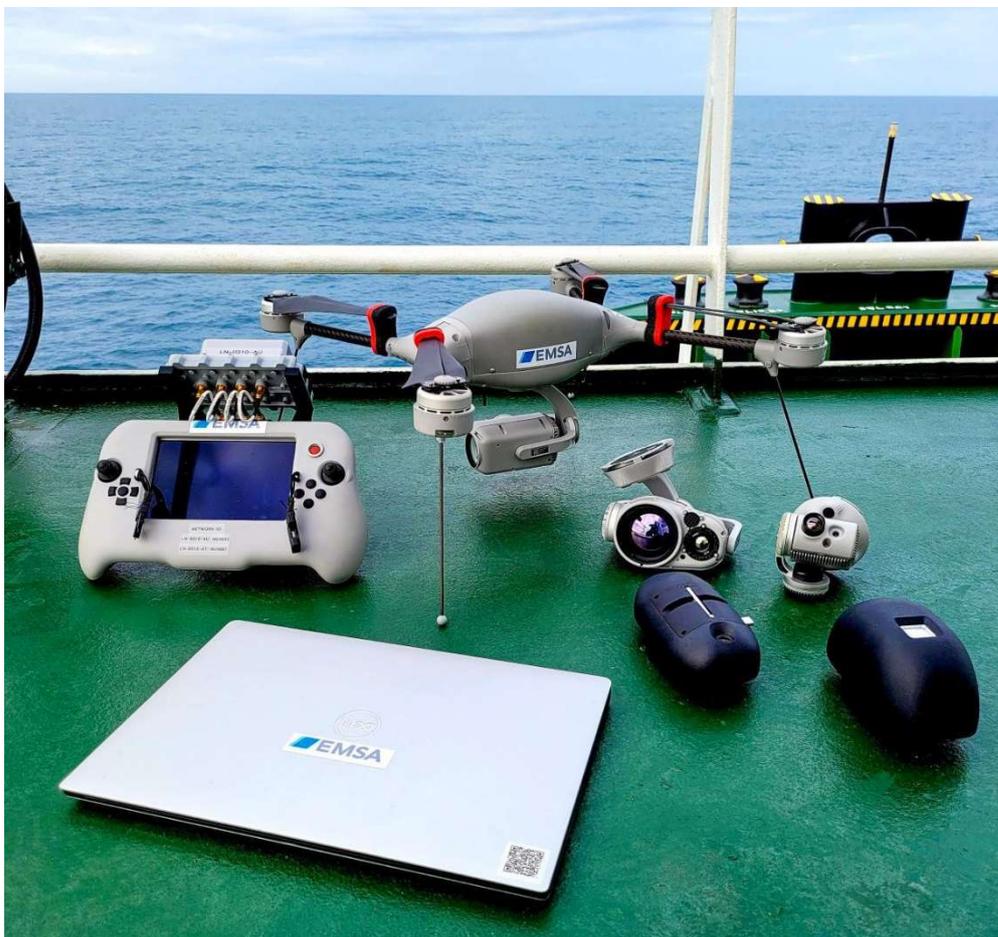
- 1) Lightweight and compact: the quadcopter RPAS was easily able to take off and land and had minimal impact on other activities taking place on board. It was smoothly integrated into the overall operations of the vessel.

Figure 5: The RPAS used on board the EMSA OSRV

- 2) Endurance and range: the RPAS has a range of 9km, and endurance of 35 minutes. On this occasion, the range and endurance were appropriate. It could fly further from the vessel for more general surveillance, and, during the ongoing clean-up operations, it was flown in closer proximity. In the case of a bigger spill, an RPAS with a longer range and endurance might bring additional benefits.
- 3) Sensors: From the EO sensor, it was possible to see that there was oil on the surface and the extent of the oil. As the leakage was not significant, it wasn't possible to categorise the spill in accordance
